# Air Infiltration of New Dwellings in Australia

Michael Ambrose and Sean Maxwell

June 2024

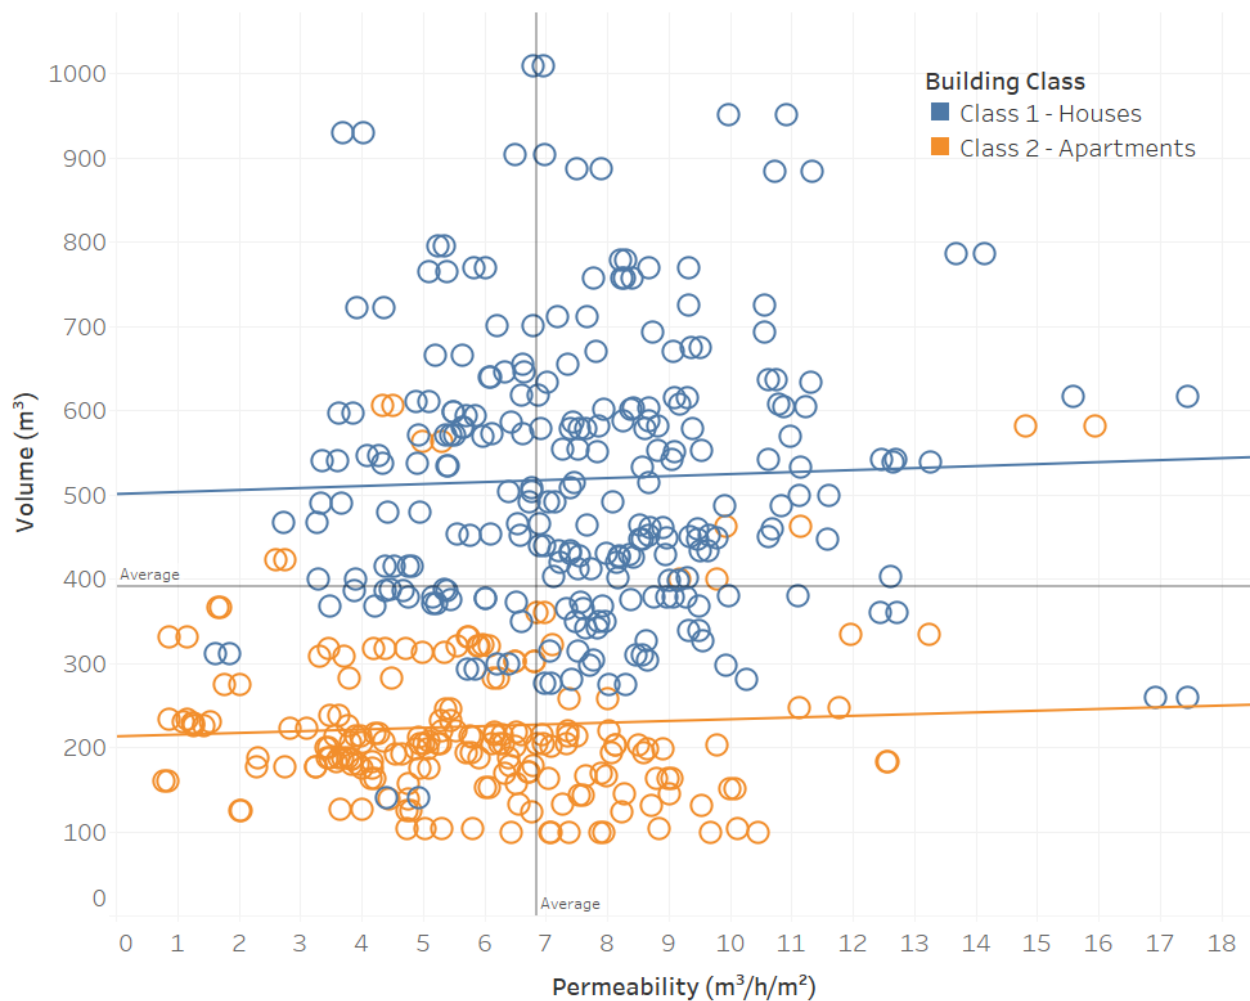
It was expected that as dwellings got larger their permeability would most likely increase and so apartments would be tighter than detached houses and that two storey houses would be leakier than single storey houses. However, as the chart below shows, a correlation between permeability and building size was not actually evident in our data.

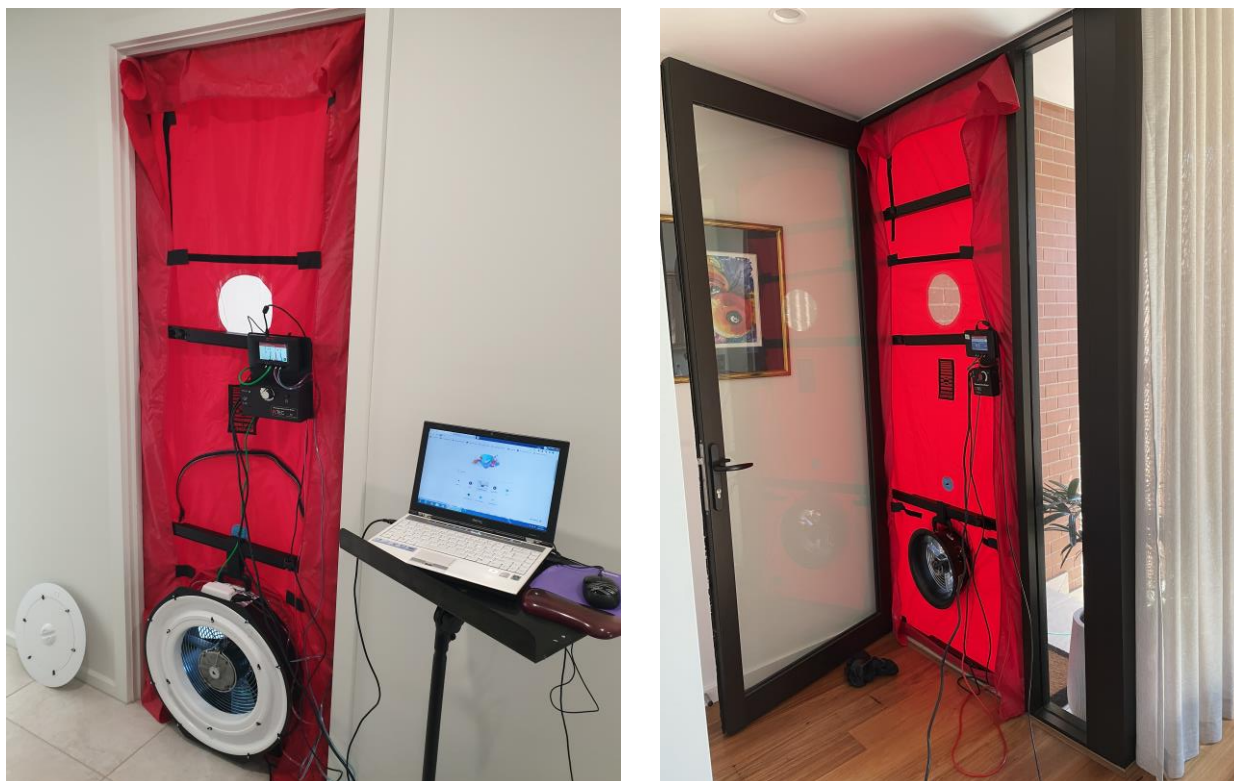
Figure 5 Typical air tightness setup

Consequently, for more direct applicability to Australian regulation and the NCC, Air Permeability ( $qE_{50}$ ) is the measurement that has been utilised for this study. All tests were undertaken by ATTMA registered and qualified testers following the ATTMA Technical Standard TSL1, which is based on ISO 9972. All dwellings had both a pressurisation (positive pressure/air in) test and a depressurisation (negative pressure/air out) test.

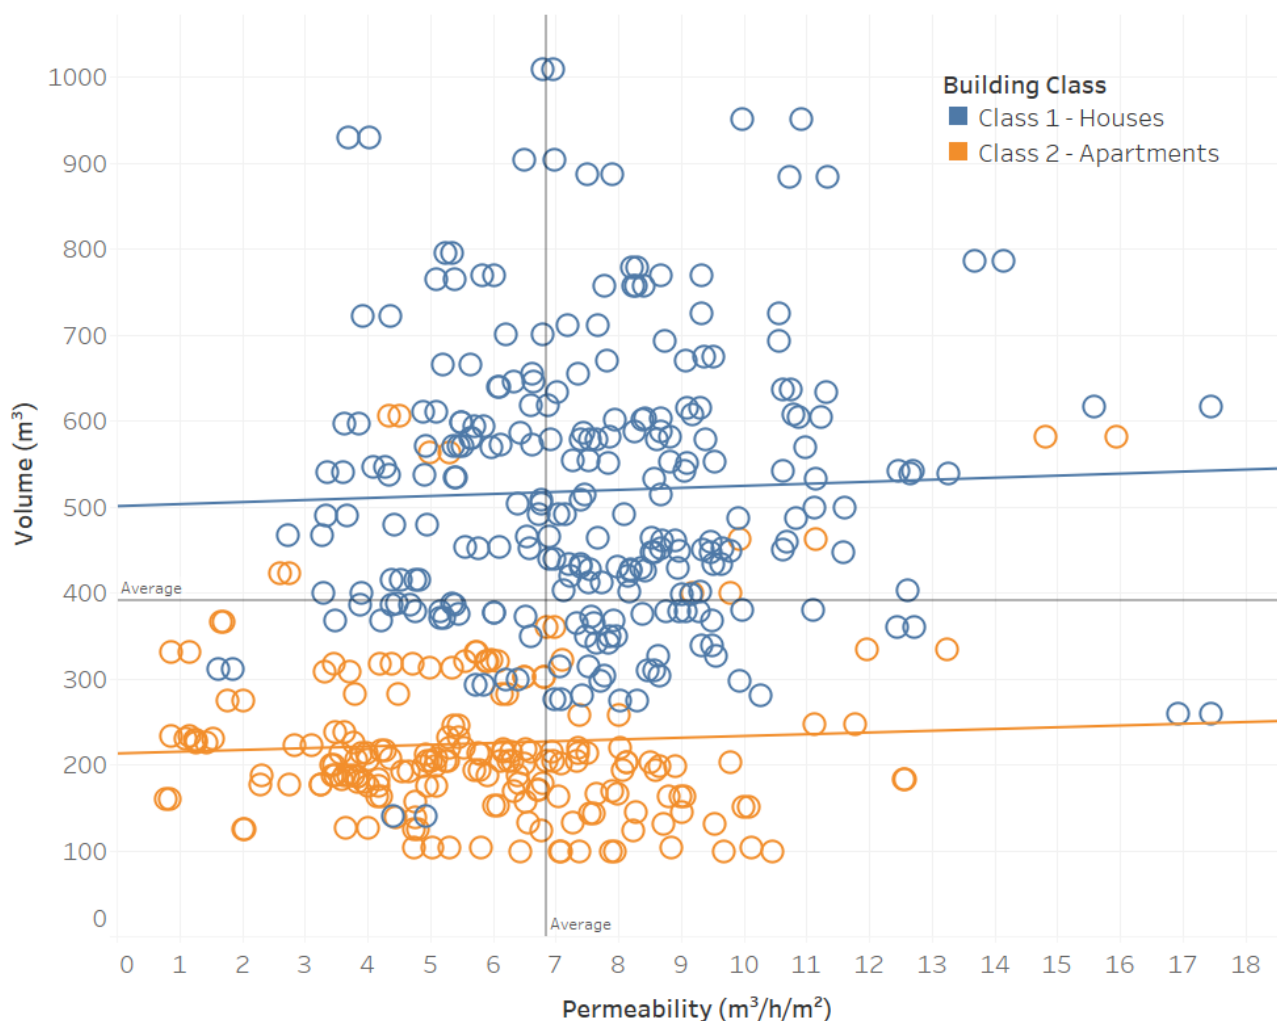
Figure 6 Permeability to dwelling volume

However, closer examination of the results obtained show that a correlation between air permeability and building size was not actually present. Figure 6 shows the plot of dwelling volume to their two air permeability tests. A linear trend has also been plotted for both dwelling classes. Although the overall trend was positive the R-squared value is below 0.1 for both, meaning that no correlation exists. This result was surprising and unexpected. The results suggest that the variability we see in air permeability rates is due to factors unrelated to the size of the dwelling. This might suggest build quality issues or the way penetrations in the building envelope are dealt with that can affect the air tightness of a dwelling rather than volume. Penetrations can include light fittings, power outlets, exhaust fans and ductwork for air conditioning systems.

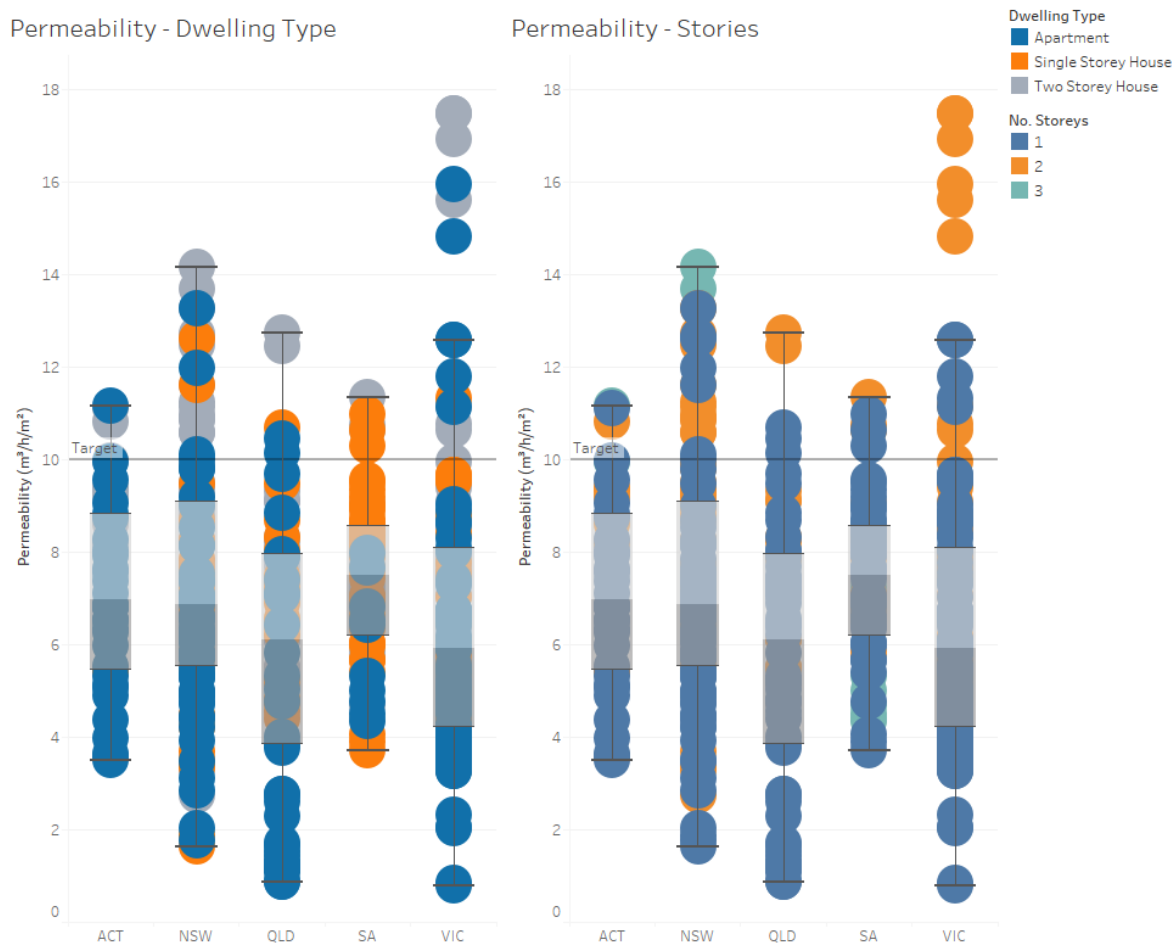
Figure 7 Permeability results for all dwellings by region

For this project a target  $qE_{50}$  of 10 m<sup>3</sup>/h/m<sup>2</sup> was selected. This is the threshold cited in NCC 2022 V2H6V3 as the performance requirement for dwellings seeking compliance through the performance provisions of the building code. Using the average permeability of each dwelling, this target was exceeded by only 9.7% of dwellings (11.7% of Class 1 and 7.1% of Class 2). Considering that most dwellings in Australia use the NatHERS provisions in the NCC, rather than the performance provisions, as the compliance pathway, it is encouraging that 90.3% of dwellings achieved the performance requirement. This demonstrates that the current performance requirement is achievable for NatHERS assessments and allows scope for future tightening of this requirement.

Overall, the results achieved show a marked improvement in the air tightness of newly constructed residential dwellings in Australia. A previous CSIRO study undertaken in 2015 tested 129 Class 1 dwellings up to 10 years old and assumed to be between a 4 and 6 star rating, to the same ATTMA standard used in this study. The 2015 study returned an average air change rate of 15.4 ACH @ 50Pa (Ambrose and Syme, 2015) whereas Table 2 shows that this study has returned an overall average air permeability of 6.86 m<sup>3</sup>/h/m<sup>2</sup>. Noting the 2015 study had results in air changes per hour ( $N_{pr}$ ) and this study used permeability ( $qE_{50}$ ), the two measurements are generally considered comparable. Figure 7 plots all results and shows that only 5 results (1.1%) exceed the average that was recorded in the 2015 study.

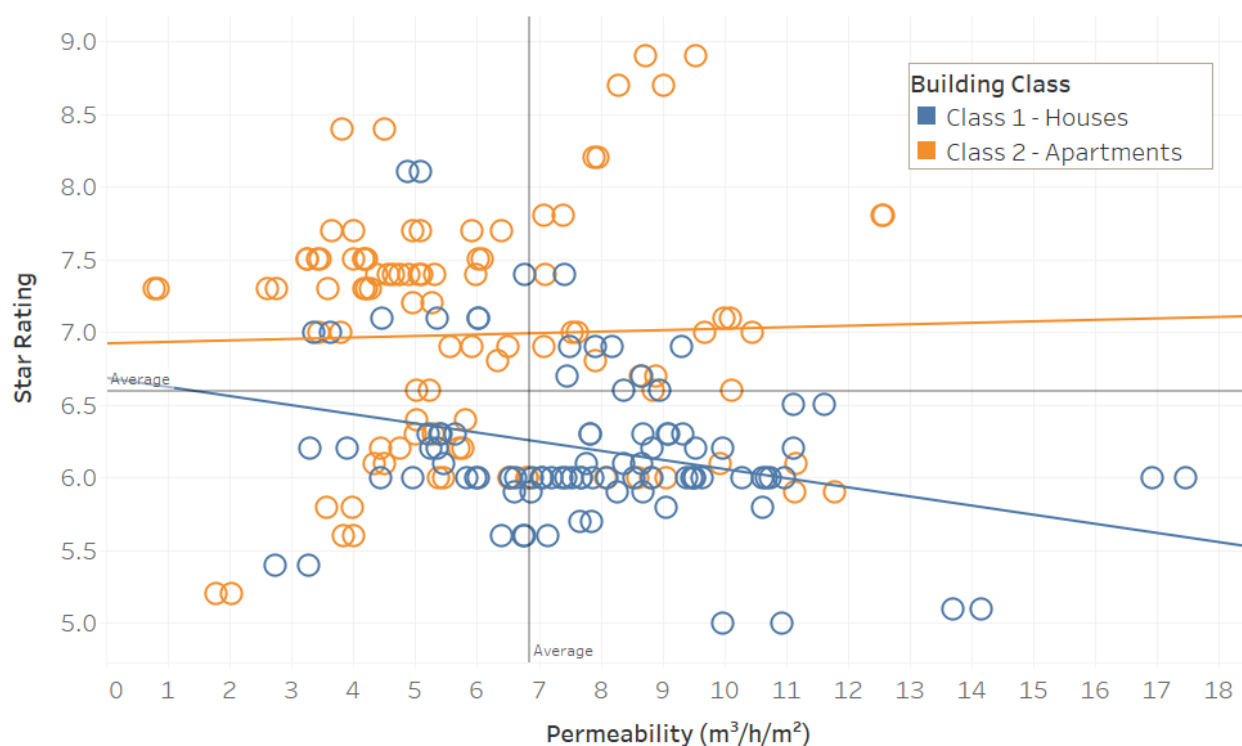
Figure 8 Permeability to star rating

Figure 8 shows the plot of air permeability to NatHERS rating as well as the trend lines for the two building classes. It demonstrates that no correlation exists between the star rating and the air permeability being achieved. Although the class 1 trend line does trend in the expected direction, that is, as star ratings increase the air permeability decreases, the R-squared is below 0.1. For class 2 dwellings the trend line is virtually flat. Indeed, the highest star rated dwelling was an apartment that rated at 8.9 stars and it returned an average  $qE_{50}$  of  $9.1 \text{ m}^3/\text{h}/\text{m}^2$  which is above the overall apartment average of  $5.8 \text{ m}^3/\text{h}/\text{m}^2$  and also above the average  $qE_{50}$  of  $6.9 \text{ m}^3/\text{h}/\text{m}^2$  that was achieved for all the dwellings that the study found star ratings for. The dwelling with the lowest  $qE_{50}$  of  $0.8 \text{ m}^3/\text{h}/\text{m}^2$  was an apartment that achieved a star rating of 7.3 stars.

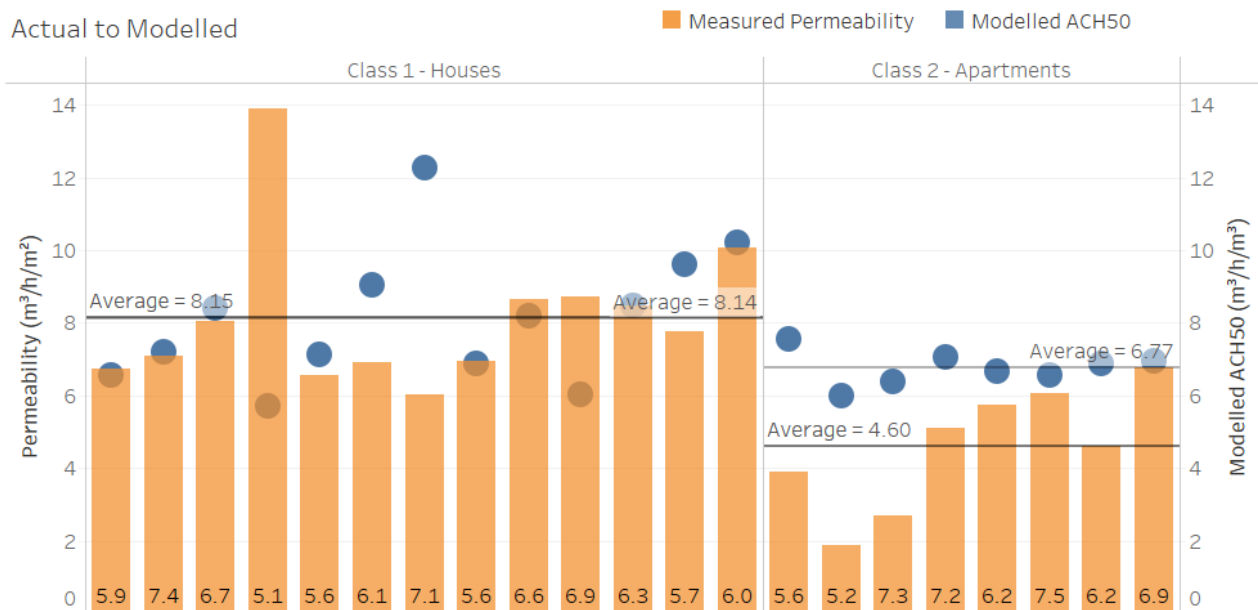
Figure 9 Measured permeability to modelled air change rate

NatHERS modelling files were available for 13 of the houses and 8 of the apartments tested. Through examination of the NatHERS modelling data the assumed air tightness value was able to be determined for each. This assumed value is what the NatHERS model utilises to determine the overall star rating of the dwelling. Figure 9 shows the comparison between the measured air permeability of the tested dwelling ( $qE_{50}$ ) and the NatHERS modelled air change rate ( $N_{pr}$ ). Although the measured results are an air permeability value and the modelled is an air change per hour value, for the purposes of this comparison they are considered equivalents. It shows that, on average, the measured and modelled values for houses was remarkably close with only a difference of  $0.01 \text{ m}^3/\text{h}/\text{m}^2$  between them. For apartments the measured (as-built) air permeability was lower than the assumed (as designed) air change rate for all apartments. On average the difference was  $2.17 \text{ m}^3/\text{h}/\text{m}^2$ . For these apartments it may mean that their as-built NatHERS star rating is slightly higher than their as designed star rating if air permeability was taken into account in a NatHERS rating. The star rating for each dwelling is listed at the bottom of each column in Figure 9 and it is interesting to note that the apartment with the lowest star rating (5.2 stars) is also the apartment with the lowest permeability value and the most airtight ( $1.9 \text{ m}^3/\text{h}/\text{m}^2$ ). This apartment is very likely to have achieved a higher star rating had the as-built permeability value been included in the as designed NatHERS rating.

Overall, this analysis shows that the assumed air tightness values used in the NatHERS design modelling correlate well with the actual measured permeability of the built dwelling, particularly with Class 1 dwellings.

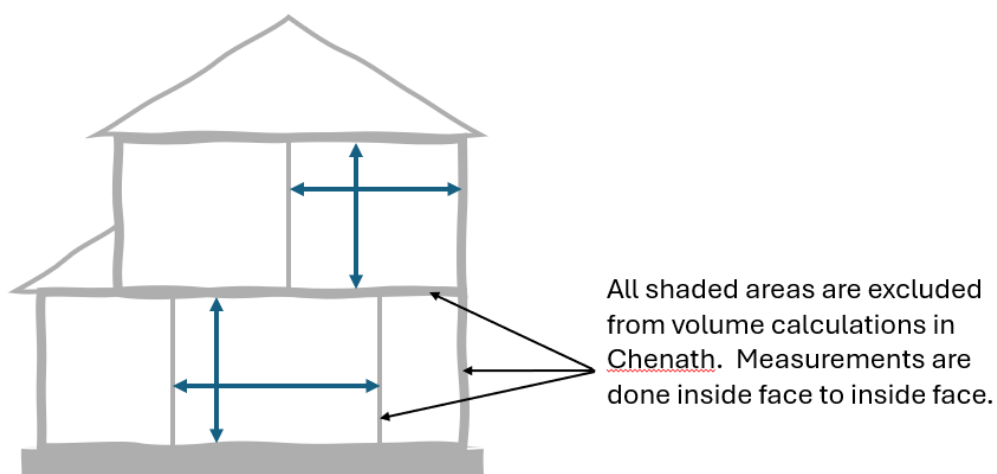
Figure 10 Cross section of house showing Chenath measurement approach

In Chenath, the calculations for the volumes are done from inside face to inside face of individual rooms (Figure 10). Consequently, the volume of walls separating internal zones are excluded for the air permeability calculations (Figure 10, 27). Likewise, the surface areas of the intersections of those interior walls with exterior floors, walls, and ceiling are also excluded. Lastly, the volume and surface area of inter-floor spaces on multi-story dwellings is also ignored (Figure 12).

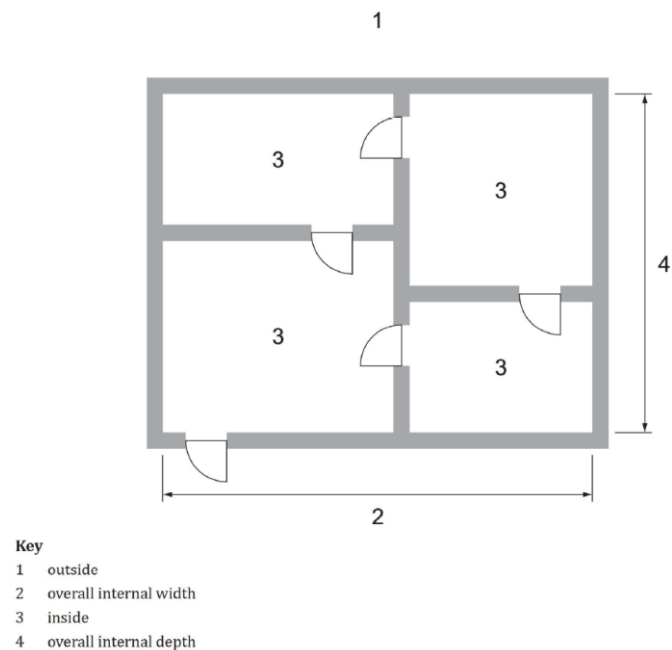
**Figure 11 Overall internal dimension of plan**

This differs from a straightforward application of the calculation method suggested by ISO 9972:2015 section 6.1 (Figure 11). This method is simpler in comparison to the Chenath engine's calculations and includes any internal volumes and their intersections with the exterior surface.

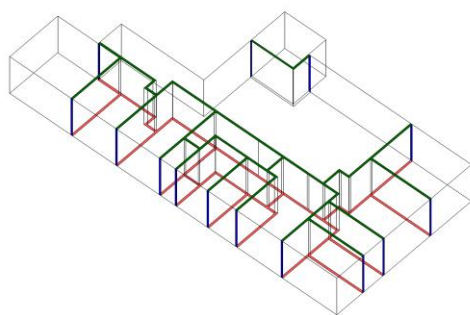
Figure 12 shows the areas of difference schematically. Clear wireframe shows the general outline of a building envelope, while coloured areas highlight differences between ISO 9972:2015 and NatHERS. Blue lines show the difference resulting from inclusion of interior walls with exterior walls. Green lines show the difference resulting from the inclusion of interior walls with exterior ceilings. Bright pink areas show the difference resulting from the inclusion of inter-floor spaces with exterior walls. The amount of difference depends on the geometry of a particular dwelling.

Single storey house

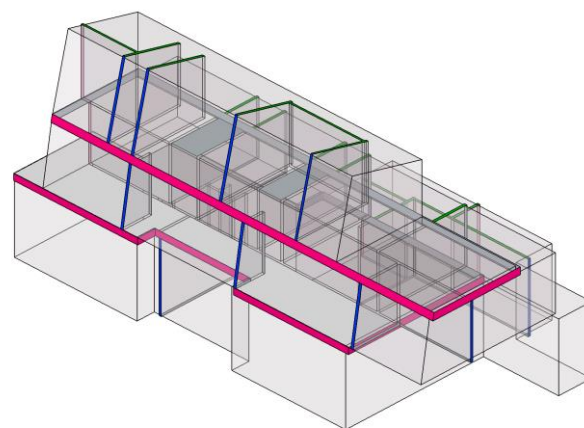
**Figure 12** Areas of difference in single and triple storey houses

Three storey house

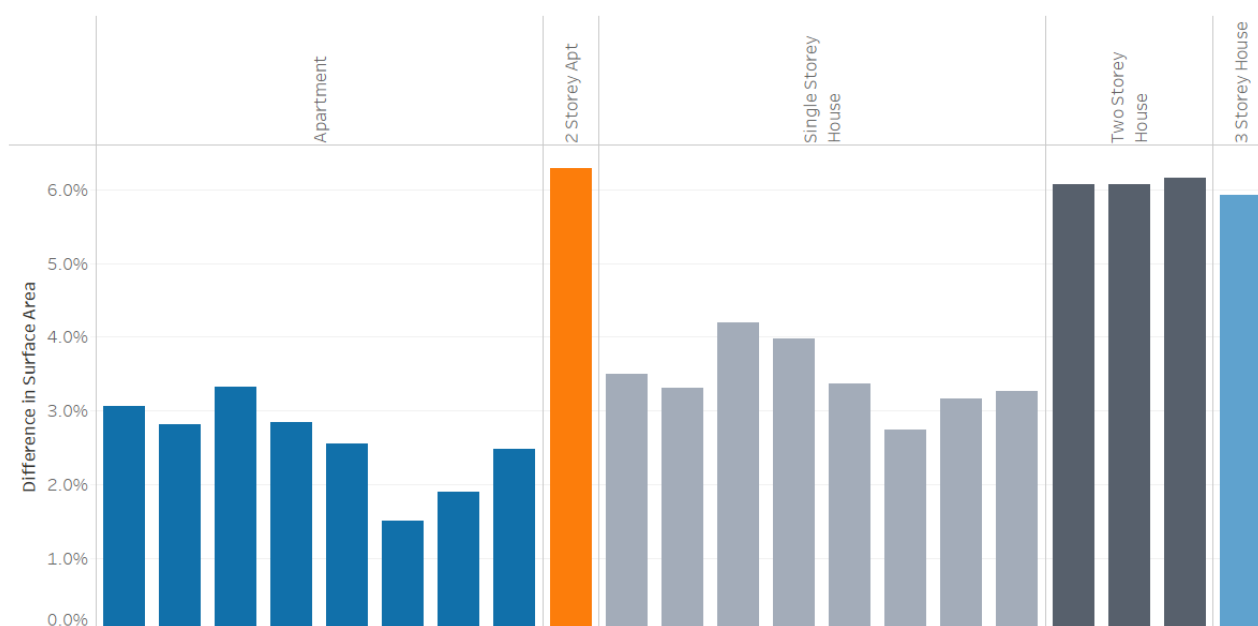
**Figure 13** Difference in surface area calculations by ISO 9972:2015 and NatHERS

Overall, there is an average difference of 3.7% between the method suggested by ISO 9972:2015 and the NatHERS calculation method, with the NatHERS figures always being smaller. The difference was smaller for apartments and single-story houses, and greater for multi-story houses, from a minimum of 1.5% up to a maximum of 6.3%, see Figure 13. The sample size is small, and only one three-story house was calculated, but there is a clear, overall trend, which is mathematically rational. The main difference with multi-story dwellings is due to the presence of an inter-floor space.

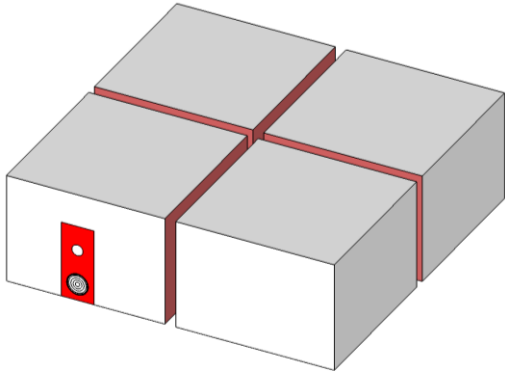
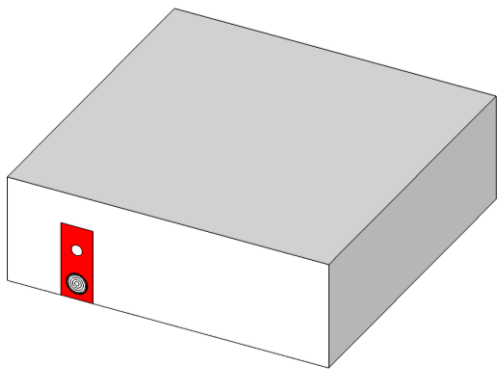
To express air permeability, an air tightness test result is divided by the dwelling’s surface area. As demonstrated above, the surface area in square meters resulting from the NatHERS method will usually be smaller, as it underestimates the total surface area of a dwelling than one resulting from the ISO 9972:2015 method. Therefore, the air permeability figure according to the NatHERS surface area calculation will be worse or leakier, than one divided by a surface area according to the ISO 9972:2015 method, see Figure 14.

| Surface area by NatHERS practice: 485/ m <sup>3</sup> | Surface area by ISO 9972:2015: 500 m <sup>3</sup> |
| Blower door result: 2000 m <sup>3</sup> /hr @ 50 Pa | Blower door result: 2000 m <sup>3</sup> /hr @ 50 Pa |

Applied in a regulatory context, demonstrating compliance with a maximum leakage target in the design stage will therefore usually be more conservative when using the NatHERS method than when using the ISO 9972 suggested method. For this reason, if a dwellings design can meet a target in NatHERS it will by default show that it meets that target according to ISO 9972:2015.

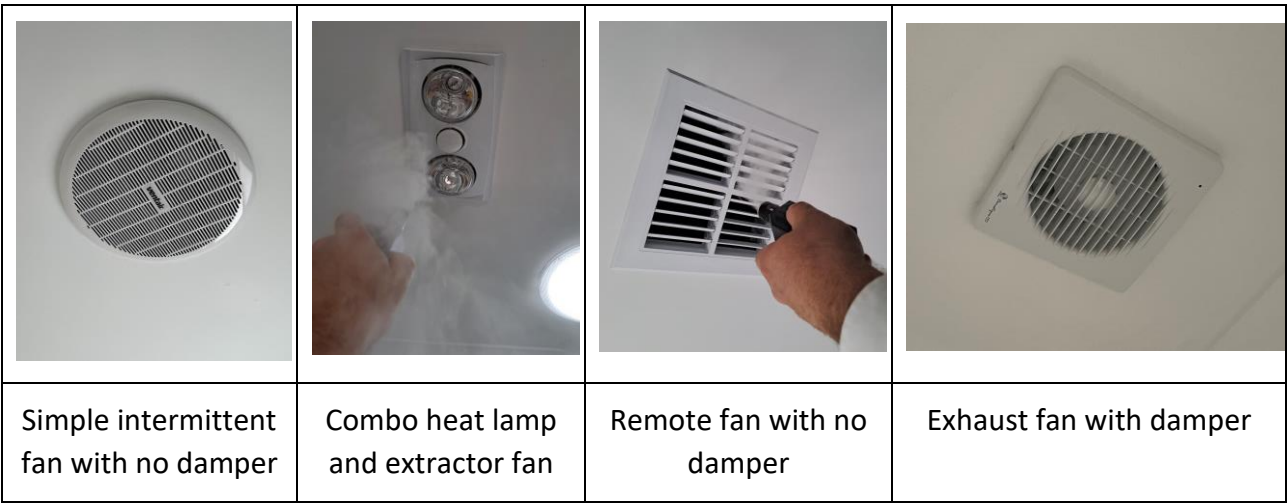
Figure 16 Range of bathroom exhaust fans

Regulations for tested dwellings built in the last 4 years required that all bathrooms have a mechanical ventilation system installed. Generally, this will be achieved through the use of a simple ceiling mounted exhaust fan controlled by occupants via an on/off switch. Each dwelling tested had at least one bathroom, but the survey allowed up to three bathrooms to be examined. Both the ventilation type and the ventilation control system were recorded in each bathroom. The simple intermittent extraction fan is by far the most common type of ventilation system installed (Figure 16). The second most common is the combination heat lamp and extractor fan (Figure 16) which is also an intermittent extraction fan. Continuous extraction fans were rarely encountered.

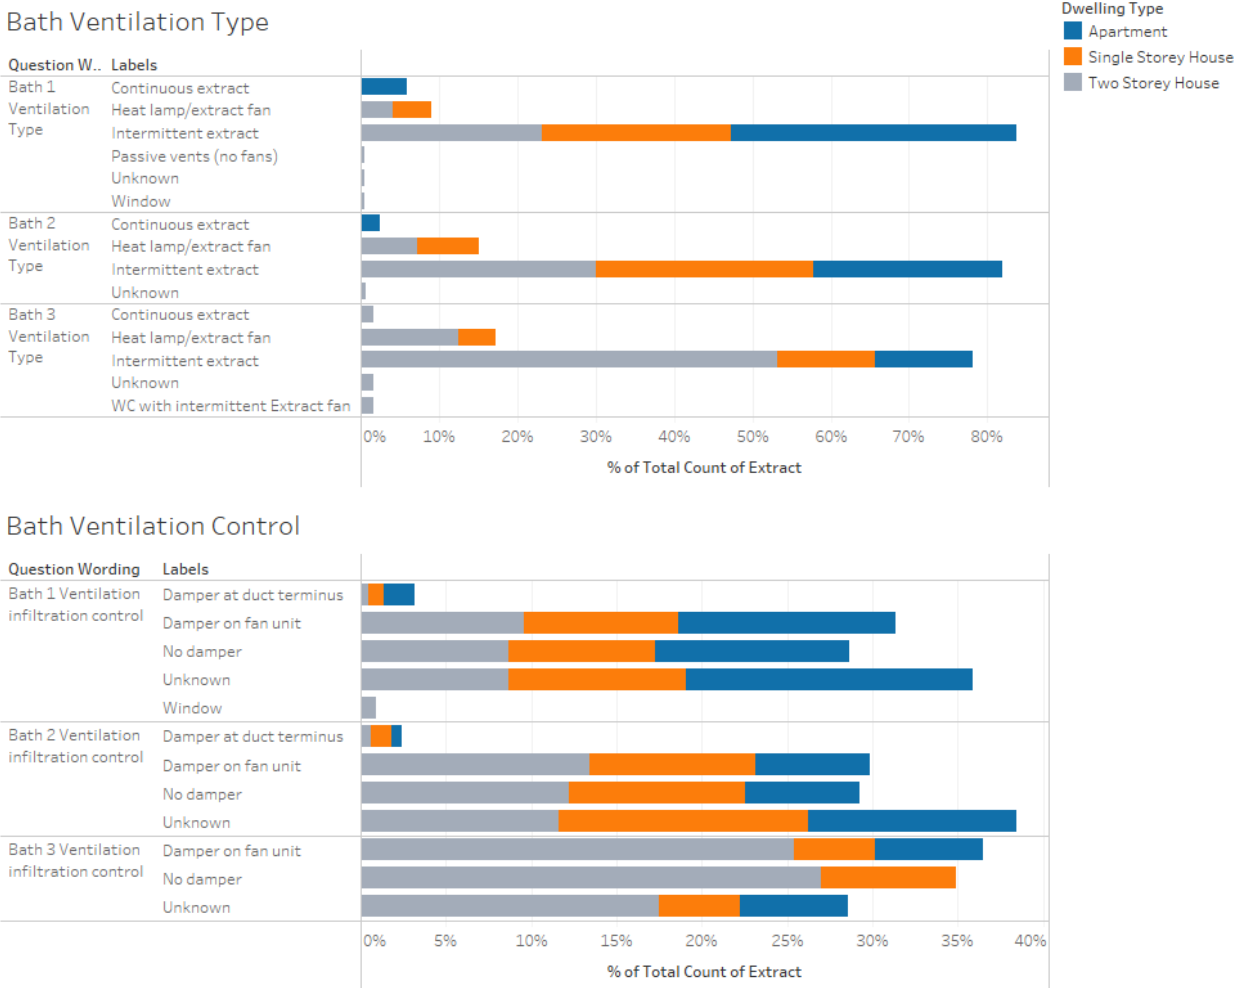
Figure 17 Bath ventilation type and control

of these dampers can become ineffectual when air conditioning systems are operating as the positive pressure within the dwelling is sufficient to push open the damper and allow conditioned air to escape. Figure 17 shows that these dampers are the most common control system used, but also shows that a significant number of exhaust fans had no dampers installed. This is surprising considering all the dwellings in this study were less than 4 years old and regulations for the requirement to have dampers on exhaust fans has been in place since 2016. This highlights a potential aspect for building inspectors to check as part of the building compliance requirements.

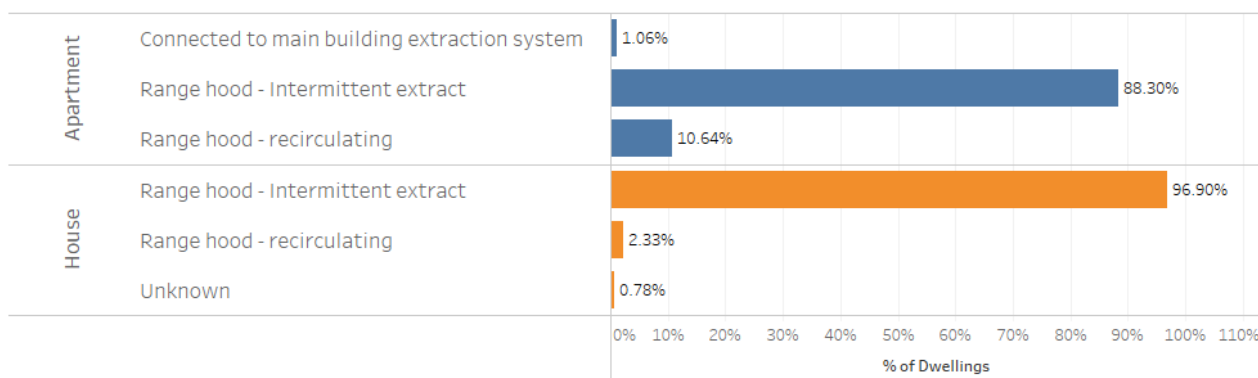
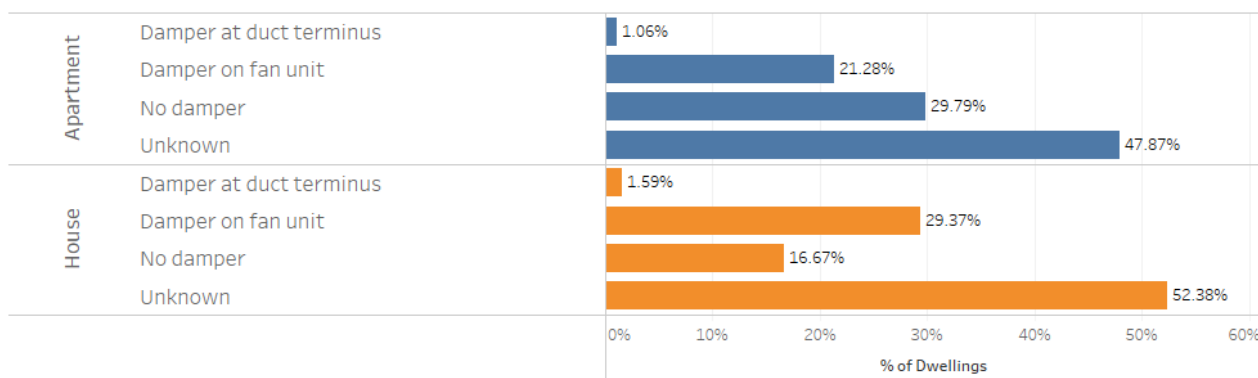
Figure 18 Kitchen ventilation type and control

Like bathrooms, kitchens are also required to have a mechanical ventilation system located over any stove cooktop. Figure 18 shows that the standard rangehood with a user-controlled extraction fan is the most common solution. 97% of houses and 88% of apartments use this approach. It is more difficult to determine the control systems on these units than it is with ceiling exhaust fans, so the high percentage of “Unknown” for ventilation control is to be expected. Where the control system could be determined, the majority of rangehoods in houses had dampers installed, but the reverse was true in apartments where the majority had no damper. Unlike ceiling exhaust fans, rangehoods are not required to have a damper if they have a filter

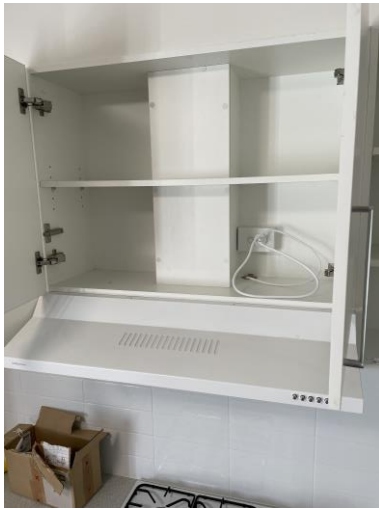
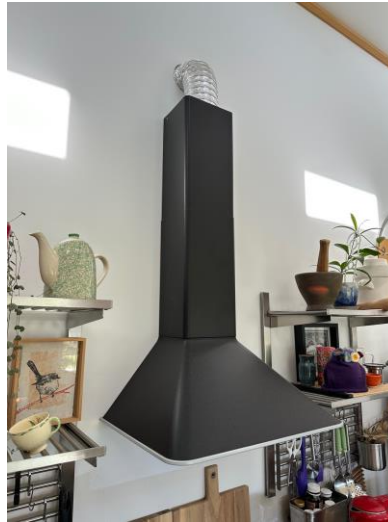
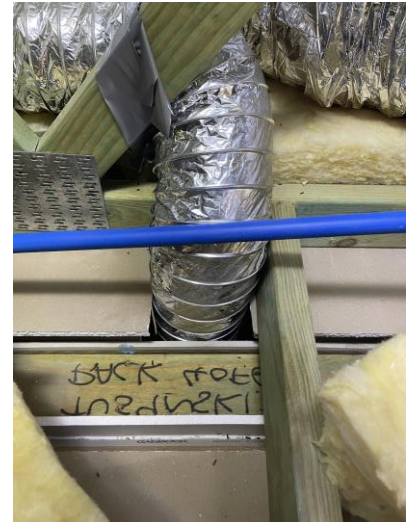
Figure 19 Kitchen rangehoods and duct setups

Typical kitchen rangehood

Ducted through wall

Duct through ceiling – note removed insulation

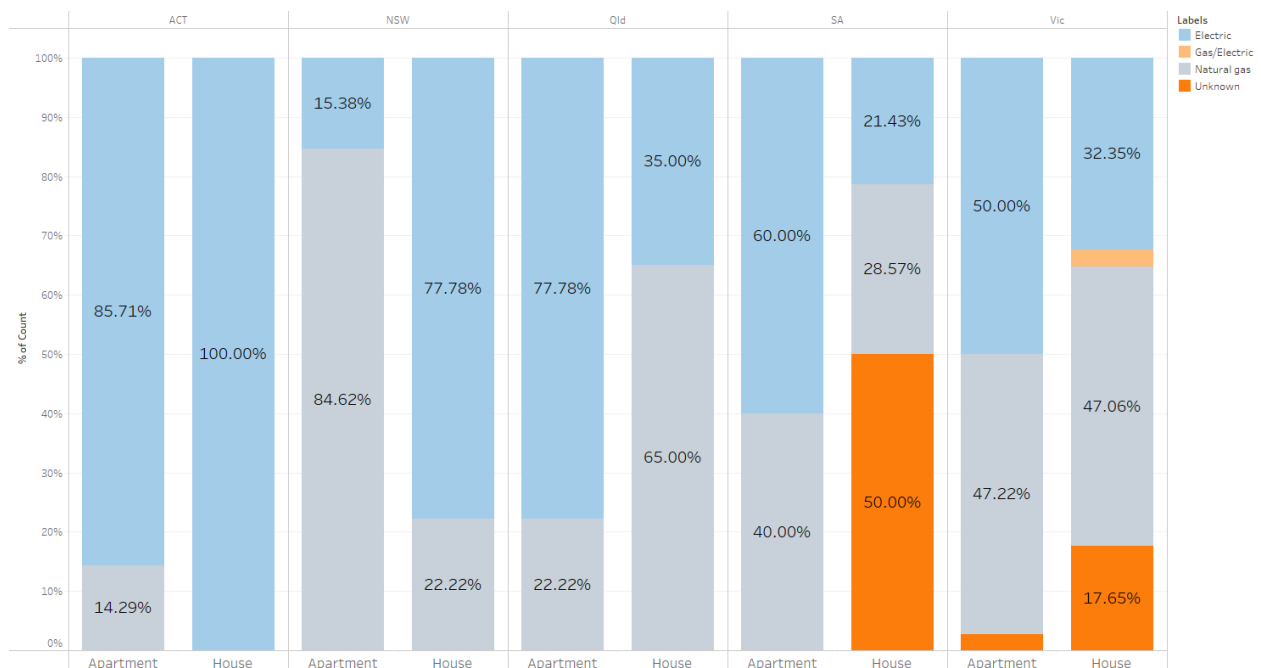
Figure 20 Kitchen range energy type

There are several reasons for having ventilation systems above kitchen stoves and ovens. The most obvious is to remove smells, steam, smoke, etc when cooking, but it also removes unwanted gases from the combustion process from gas stovetops. Figure 20 shows the energy types within each region and by dwelling type. Dwellings in the ACT mainly have all electric ranges, while apartments in NSW are mainly gas stovetops. Victorian homes have traditionally had a high uptake of gas based appliances, but the Victorian dwellings in this study have a relatively even split between gas and electric.

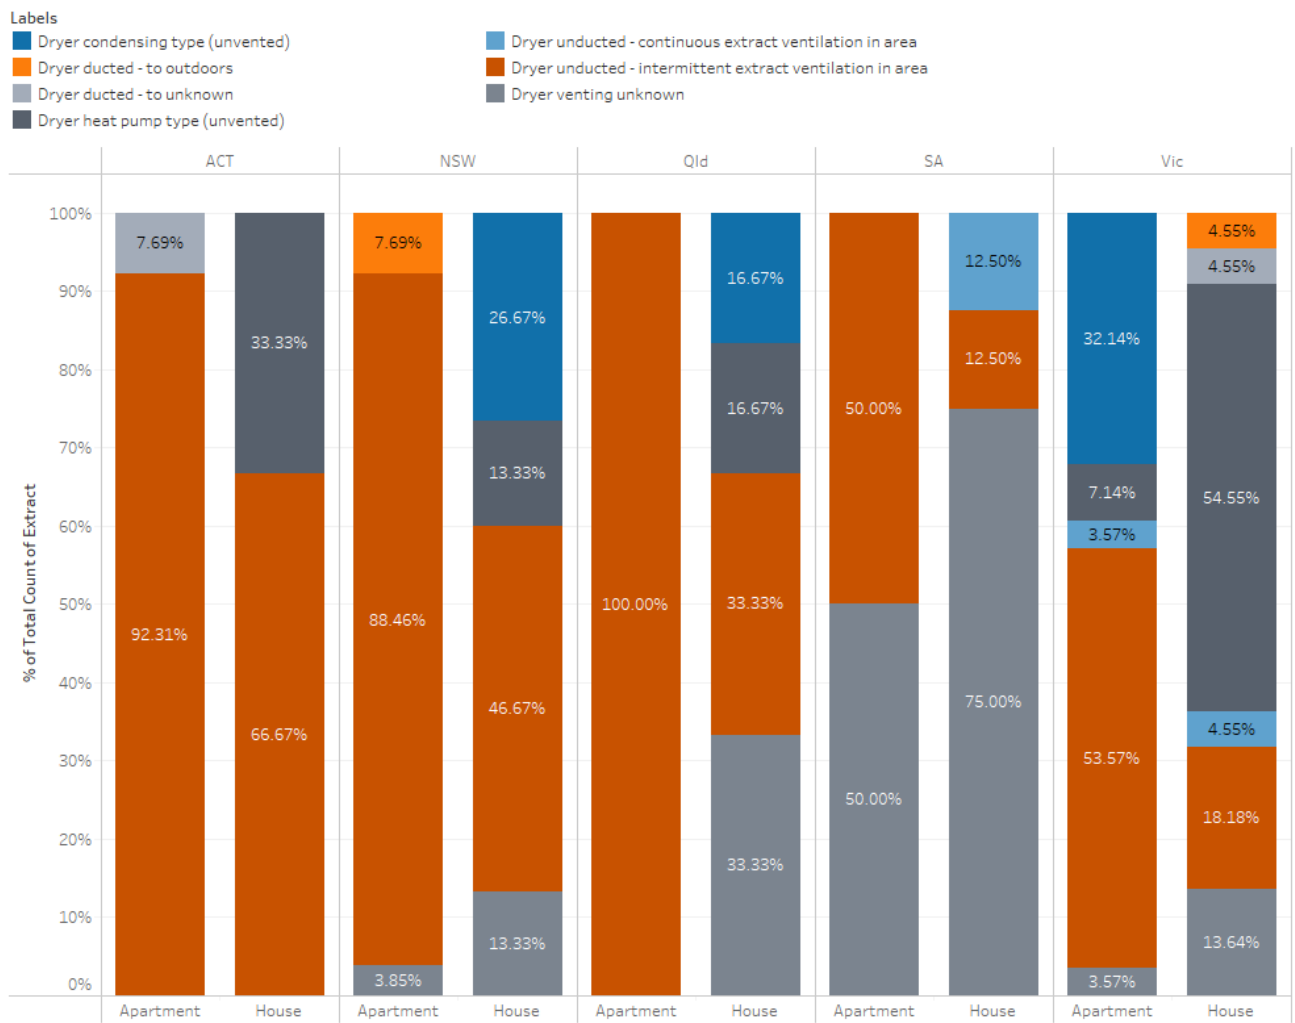
Figure 21 Clothes dryer type

Within our study, most dwellings did have a clothes dryer, although in Queensland 60% of apartments and 40% of houses had no dryer. Amongst those dwellings that did have a dryer the majority were traditional venting dryers with no or unknown external venting and relied on intermittent extraction of humid air via a ceiling exhaust fan or an open window. Figure 21 shows the types of clothes dryers that were present. The most efficient dryers are heat pump dryers which recover most of the energy in the humid exhaust air and reuse it to dry the clothes (Milne and Reardon, 2022). It is interesting to note that in Victorian houses that had dryers, 55% were heat pump dryers.

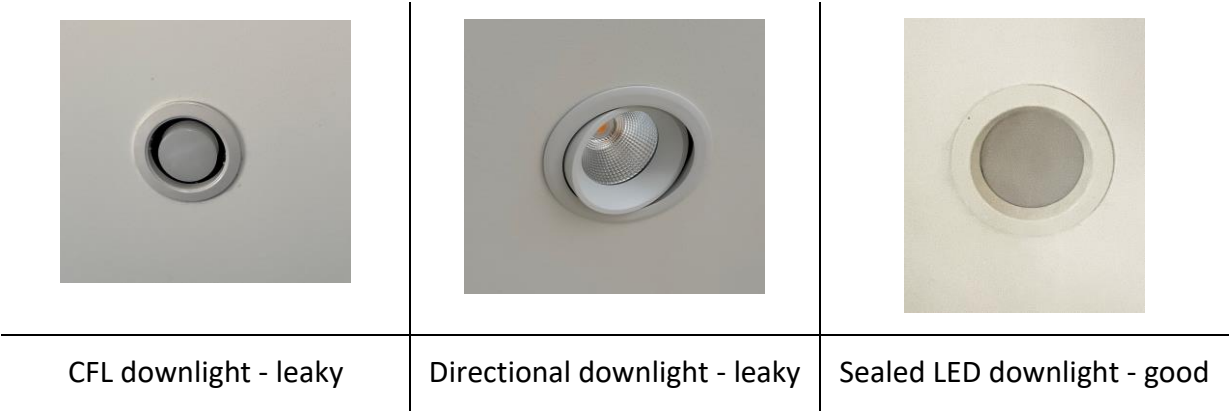
Figure 22 Downlight types

permeability as well as breaks in the insulation layer on the ceiling. Modern downlights will usually be LED lighting. These are not only significantly more energy efficient than old halogen lighting, but many LED downlights (IC rated) also allow insulation to be installed over them. This means that a continuous insulation layer is possible across the ceiling leading to much greater thermal performance. In addition, modern LED downlights are often sealed units that do not require ventilation, so air infiltration through them is minimised. Nevertheless, downlights can still be a source of air leakage in modern dwellings if they have been poorly installed.

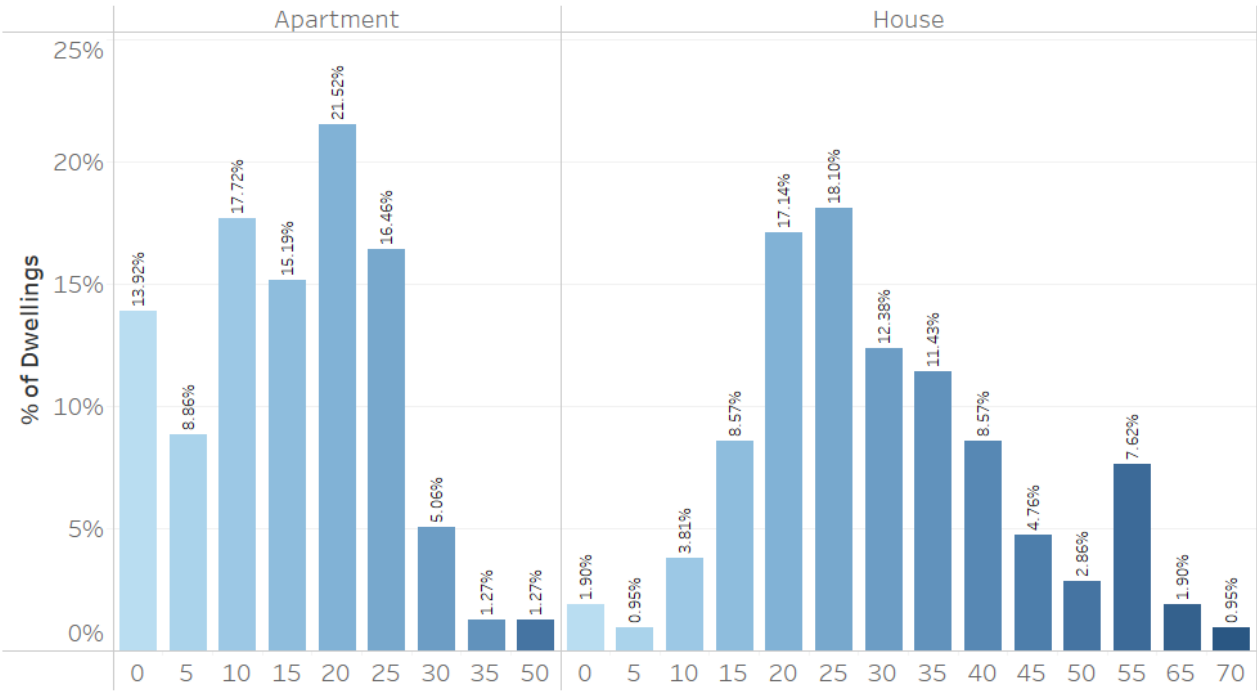
Figure 23 Downlight number distribution by dwelling type

On average, there were 17 downlights installed in each apartment in this study and 37 downlights installed in each house. Figure 23 shows the downlight number distribution by dwelling type. Over 90% of apartments have less than 30 downlights while over 13% of houses had 50 or more downlights installed. Every installed downlight is a potential source of air leakage, so careful planning to optimise downlight use and placement will reduce overuse of downlights and sources of air leakage.

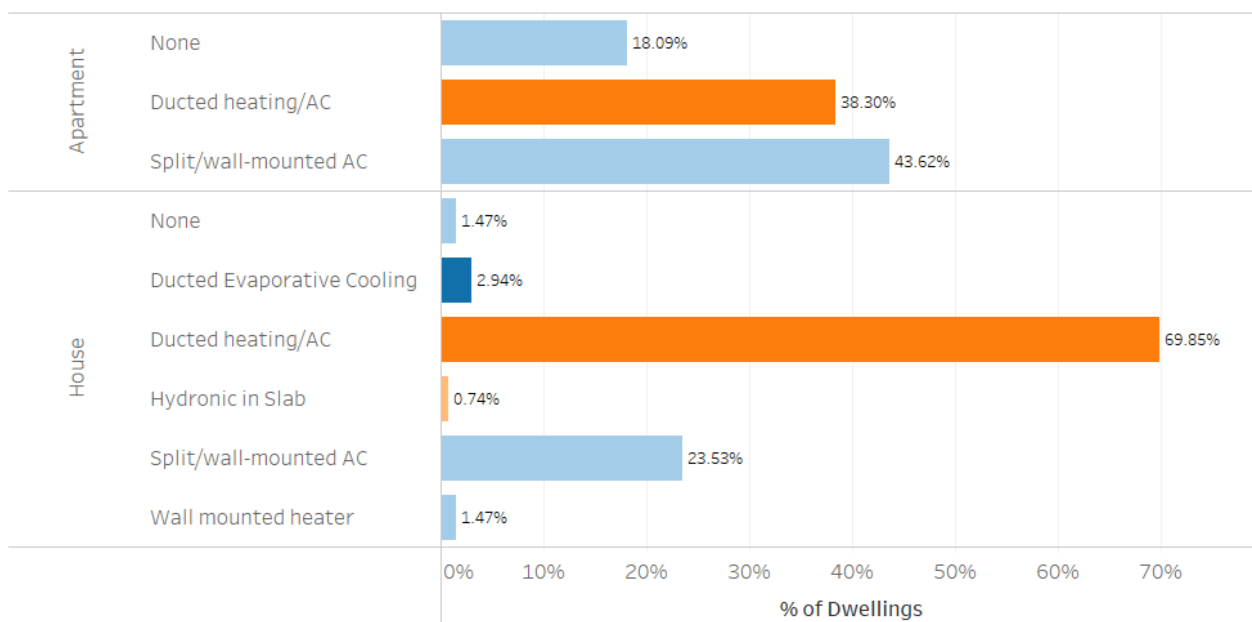
Figure 24 Heating/cooling systems installed

70% of houses and 38% of apartments had ducted heating/AC systems installed. Split AC systems were more common in apartments (44%) than houses (24%). Only a very small percentage (3%) of houses had ducted evaporative cooling installed. All these systems have penetrations in walls and/or ceilings that are potential air leakage points. Ducted systems can be significant causes of air leakage as the registers in the ceiling are usually unable to be closed off when not in use. This allows direct access to the ductwork in the ceiling space which has multiple opportunities for air leakage through joins and junctions that have been poorly sealed or through damage to the ductwork itself.

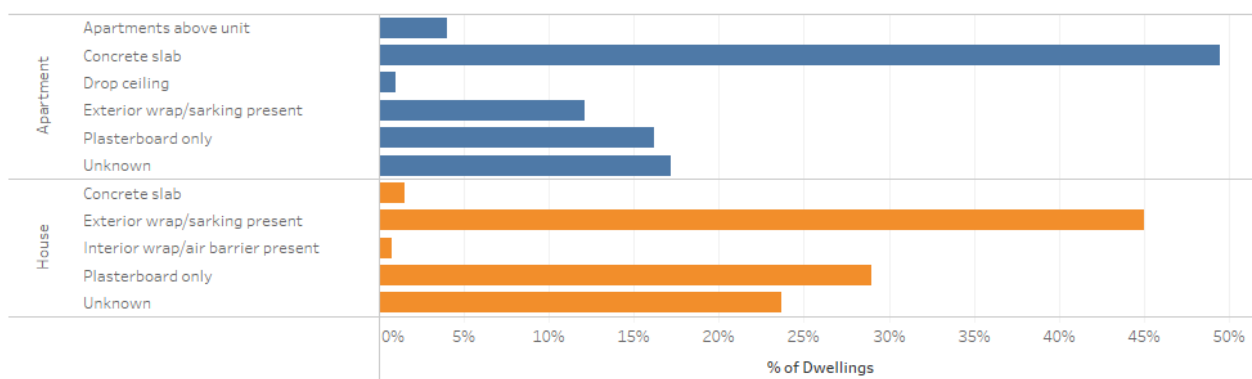
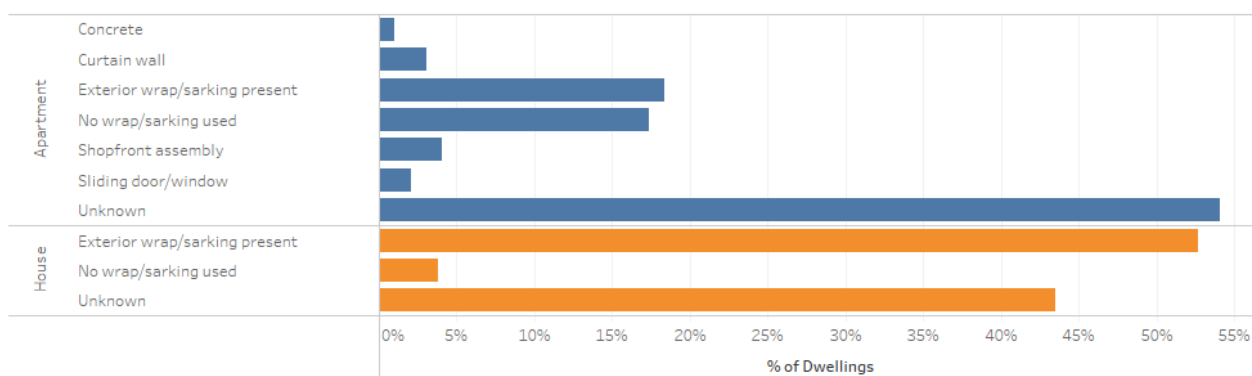
Figure 25 Types of barriers used in roof, ceiling, and wall structures

Roof Ceiling Barriers

Exterior Wall Barriers
