# Air Infiltration of New Dwellings in Australia

Michael Ambrose and Sean Maxwell

June 2024

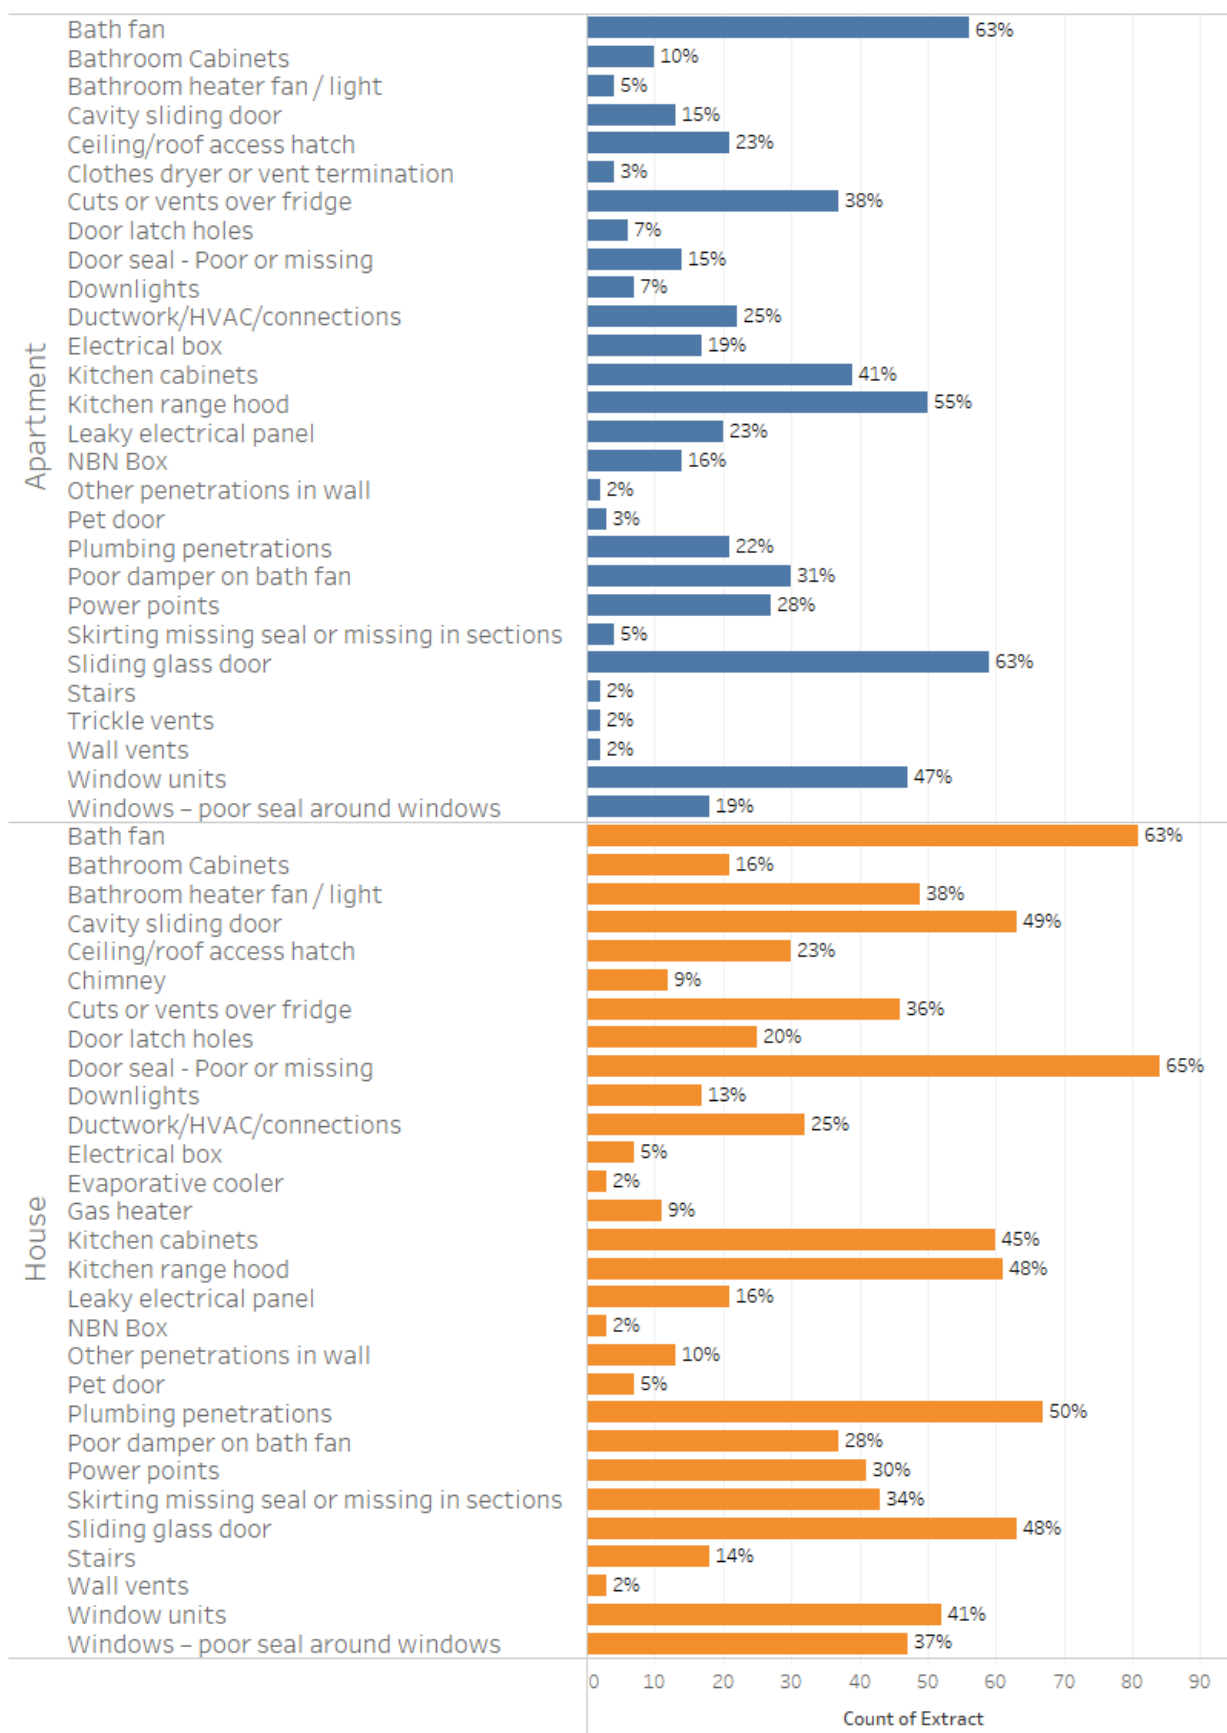
Figure 26 Identified leakage points

The most reported air leakage point for apartments (59 reports) was sliding glass doors with 63% of apartments having this issue. For most apartments the sliding door will usually lead to a balcony and is often the primary means of obtaining outside air and natural ventilation. These doors get high levels of use and consequently this can lead to damage of weather and door seals. Install quality and the quality of the door system itself can also lead to poor performance of the door over time. Sliding doors were also a major issue in houses (63 reports) with 48% of houses having this issue.

For houses the most reported issue was poor or missing door seals. This was reported 84 times and occurred in 65% of houses. This is a similar issue to sliding doors, although this focused on external doors that are not sliding doors, so primarily front entrance doors. This is why this issue was not as significant in apartments. 15% reported this as an issue as many apartment entry doors are accessed from internal corridors. As with sliding doors, frequent use can lead to the quick degradation of the seals, so regular maintenance is required to maintain their effectiveness.

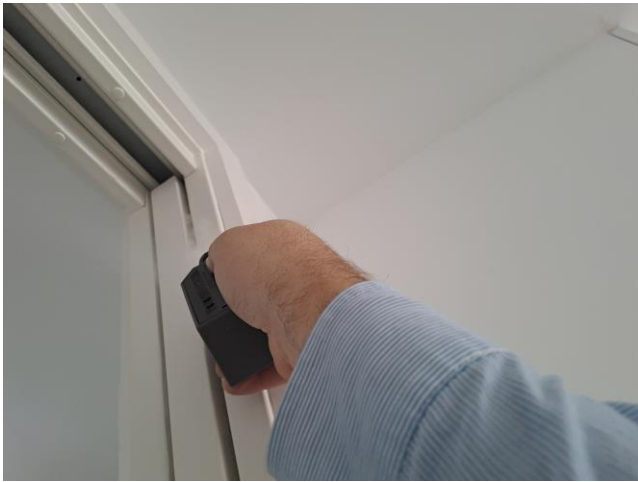
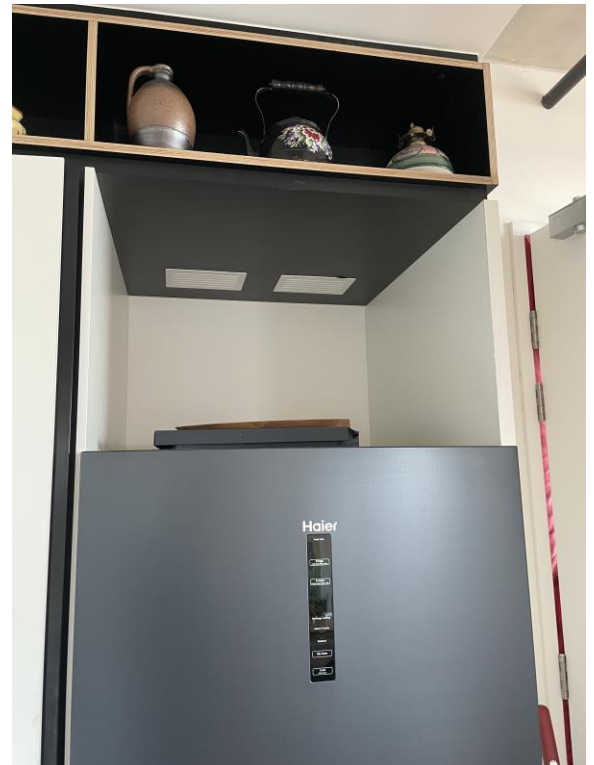
Figure 27 Typical leakage points identified

Internal cavity sliding door

Sliding glass door

Vent over fridge

Many other leakage points were identified, and often simple solutions could be found to rectify these leaks. Various penetrations through walls were a common issue that could easily be resolved through gap sealants being used while more structural related causes need to be addressed at the time of construction. For example, cavity sliding doors were identified as a leakage point in 49% of houses and 15% of apartments. Cavity sliding units are typically unsealed framed units that fit within the wall cavity. Simply enclosing these units before install into the wall cavity would greatly reduce air leakage through sliding doors. Trying to seal cavity sliding units after they are installed is a complicated and expensive task.

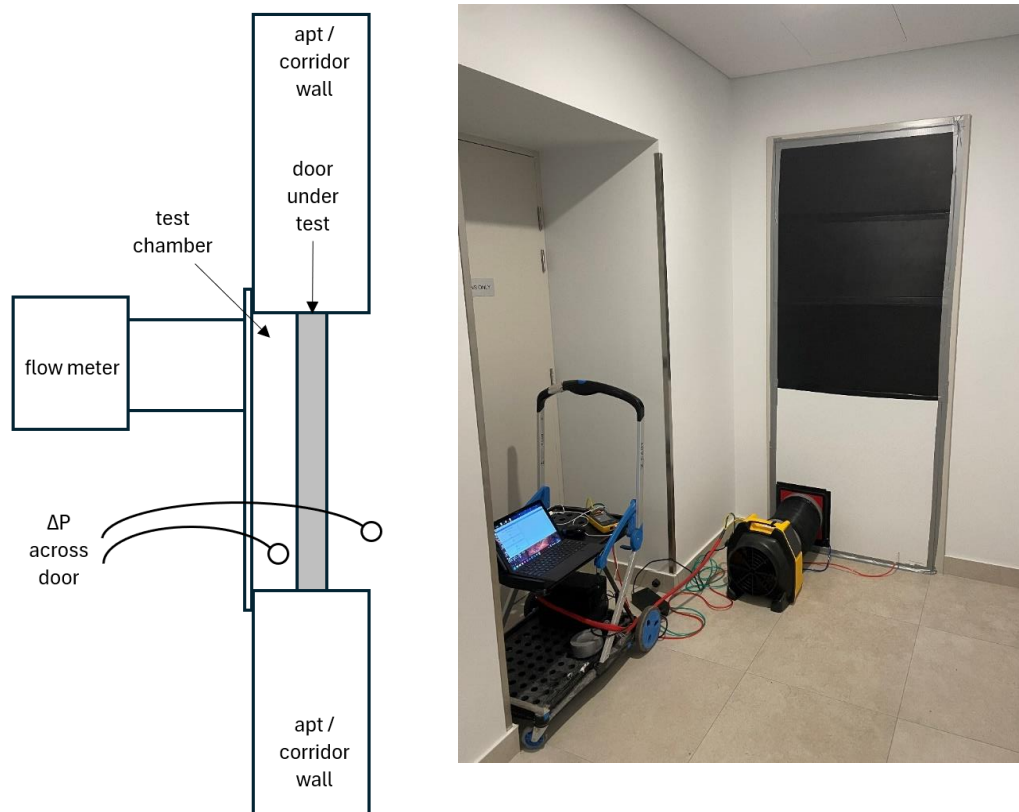
**Figure 28 Door leakage test rig setup**

Above 15 Pascals, it can be seen that the door under test may be pushed away from its seals to the point that it possibly leaks more than in typical operation at lower pressures. For this reason, test pressures were generally capped at about 15 Pascals.

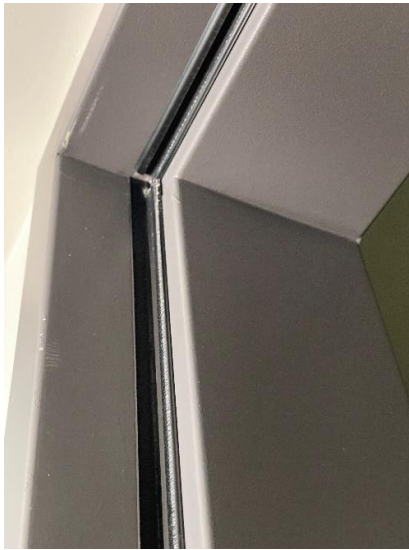
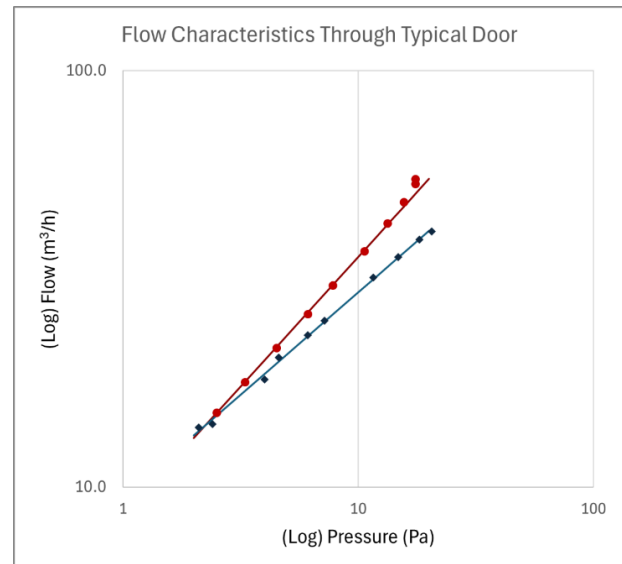
**Figure 29** Flow characteristics through typical door

For these reasons, the tests were conducted under negative pressures and were generally capped at about 15 Pascals. Data was entered into Retrotec Fantestic software for calculation of a projected leakage rate at 50 Pascals for comparison.

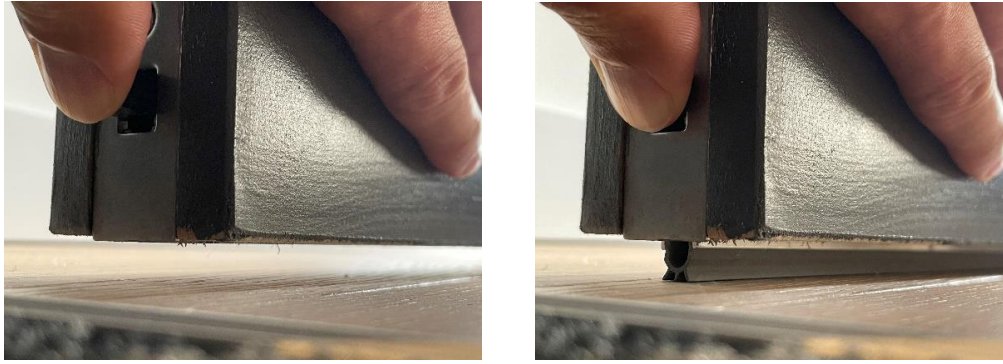
**Figure 30 Drop seals**

Each building had doors with “drop seals”, or trigger-activated door seal mechanisms. When the doors shut, they push an adjustable pin in that drops a seal to close the gap under the door, see Figure 30. When the door opens, the pin releases and the mechanism pulls the drop seal out of the swing path of the door. This has the benefit of maintaining the long-term condition of the door seal. In general, the door seals did a good job of cutting down air movement through the door. Some of the doors had poorly-adjusted door seals, and this was likely the cause of higher leakage rates through some of the them.

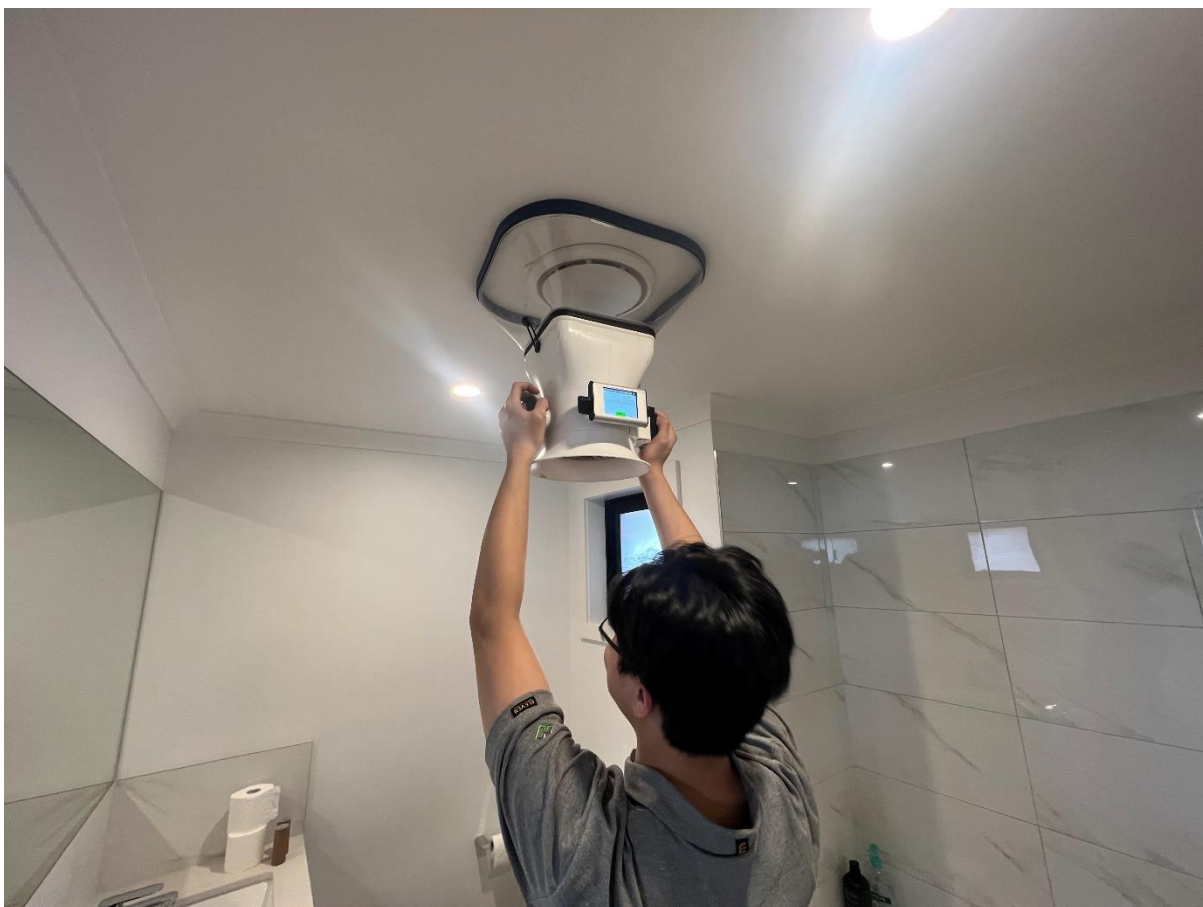
Figure 31 Measuring exhaust fan ventilation

Measurements were made with fans in different operating modes. One was with the door to the zone open, and one with the door closed. This was to observe the effect that closing doors had on the performance of the system. For example, if bathrooms do not have sufficient door undercut or other gaps, they may be starved for pressure relief and may not function effectively. Flow rates were measured with doors open and closed, and pressure drop across the door was measured when closed. Finally, visual observation of the door undercut was made to estimate the size.

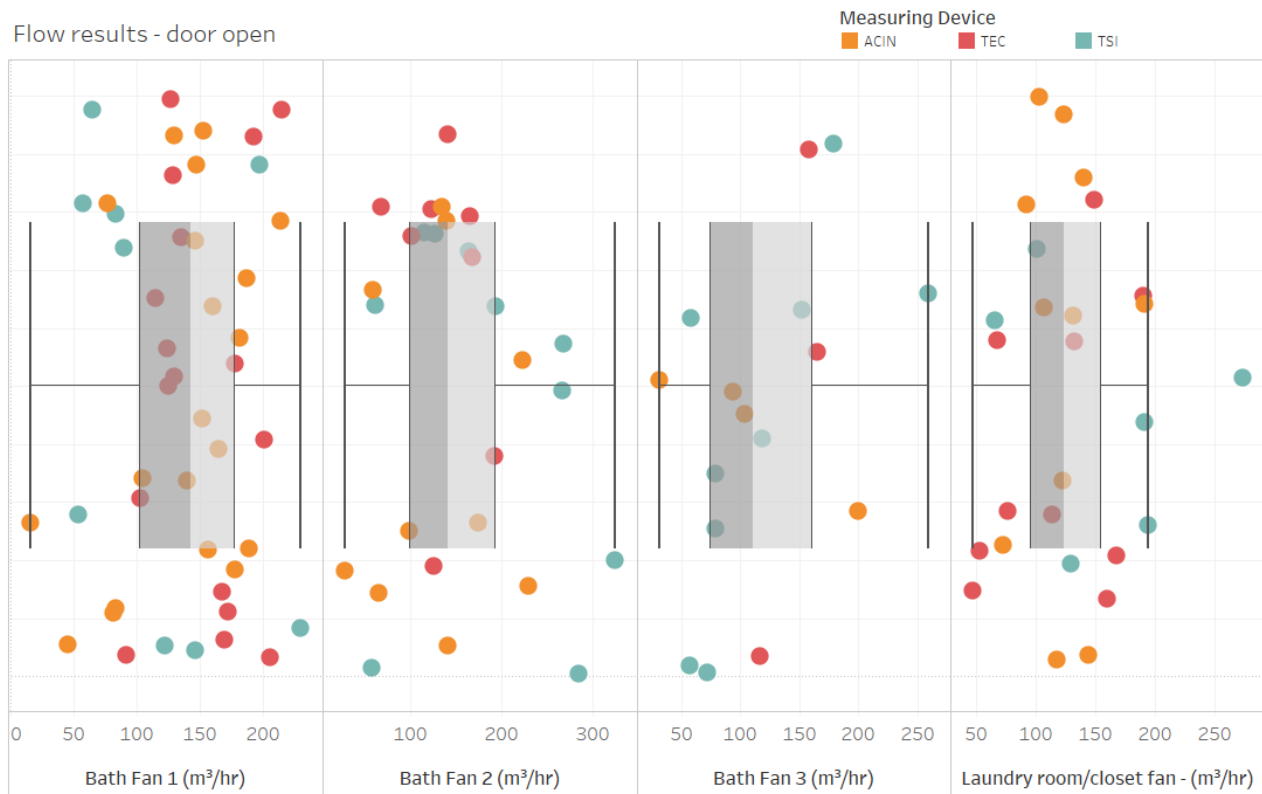
Figure 32 Flow rates for exhaust fans with door open

In total, airflow measurements were made from 121 different fan installations at 51 separate dwellings. Some were very large and drew large flow rates; others were small and drew much lower rates. The lowest measured flow was 16 m<sup>3</sup>/hr, but there were others that were likely lower. These lower rates could not be measured with the equipment on hand. Figure 32 shows a box and whisker plot of the flow results for exhaust fans in various locations all with the door to the zone being open. A range of measuring devices were used for the testing, these are noted on Figure 32.<sup>1</sup>

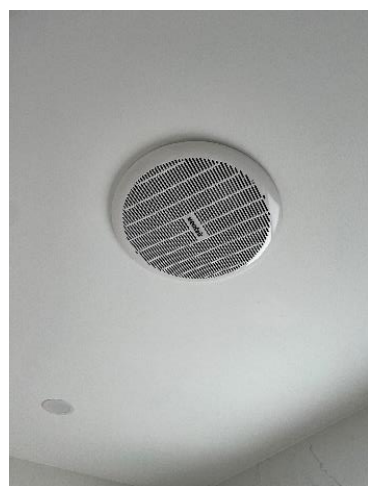
The systems observed included individual ceiling units, bathroom units with integrated heating lights, and remote in-line fans with ductwork to single or multiple ceiling registers. Figure 33 shows some of the typical ceiling exhaust fan units that were tested.

Single bath or laundry fan

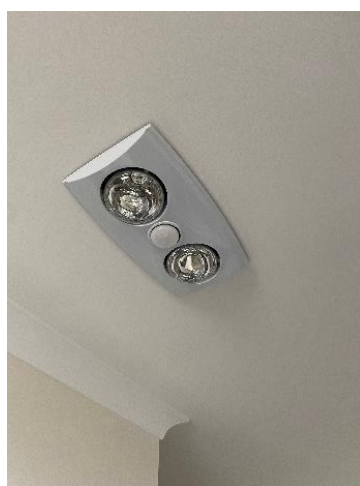
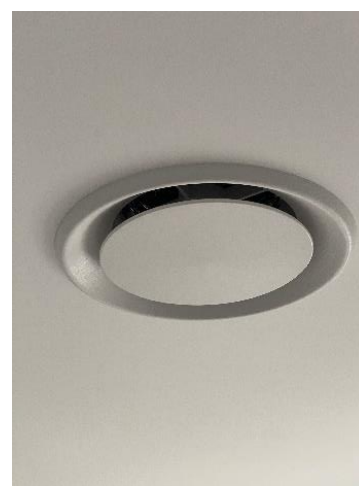
**Figure 33** Typical types of ceiling exhaust fans

Unit with integrated heating light

Ceiling vent with remote in-line fan

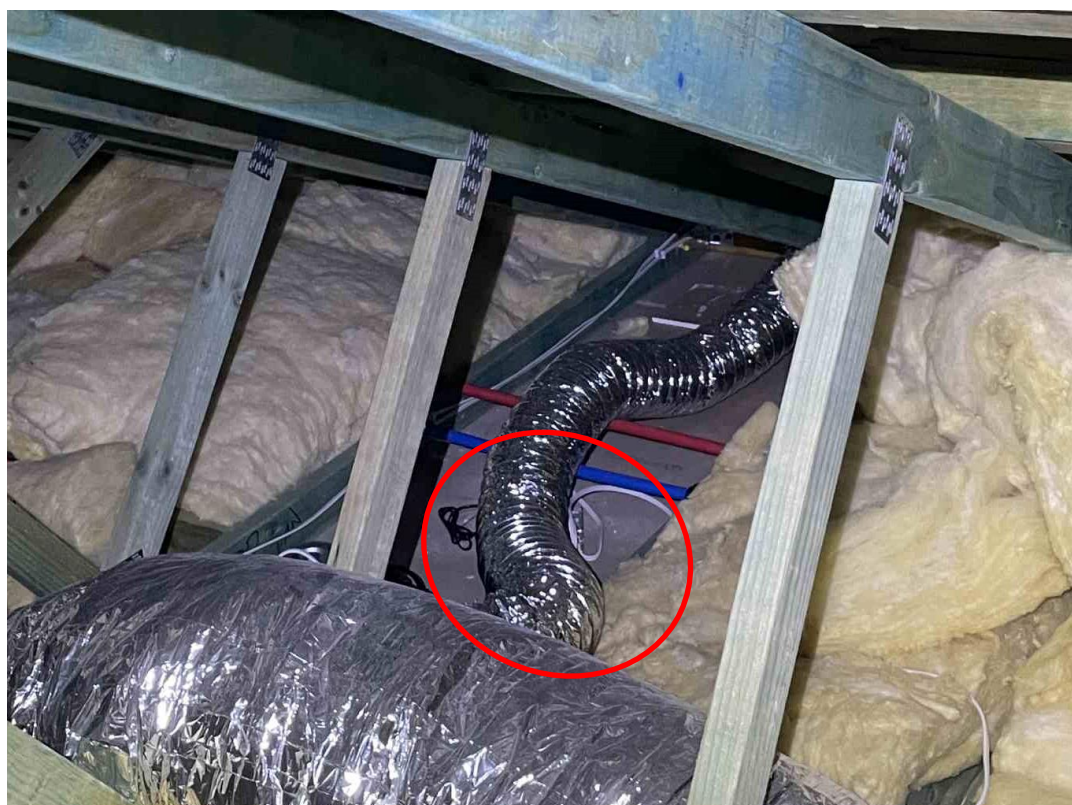
Figure 34 Crimped excess exhaust fan ductwork

Some fan installations were subject to poor ductwork installation. In a few houses, some fans were performing normally, while a single fan was specifically low. Upon investigation in the roof space, it could be seen that the ductwork connected to the fan was longer than necessary, winding, and crimped in some areas, all contributing to lower airflow (Figure 34).

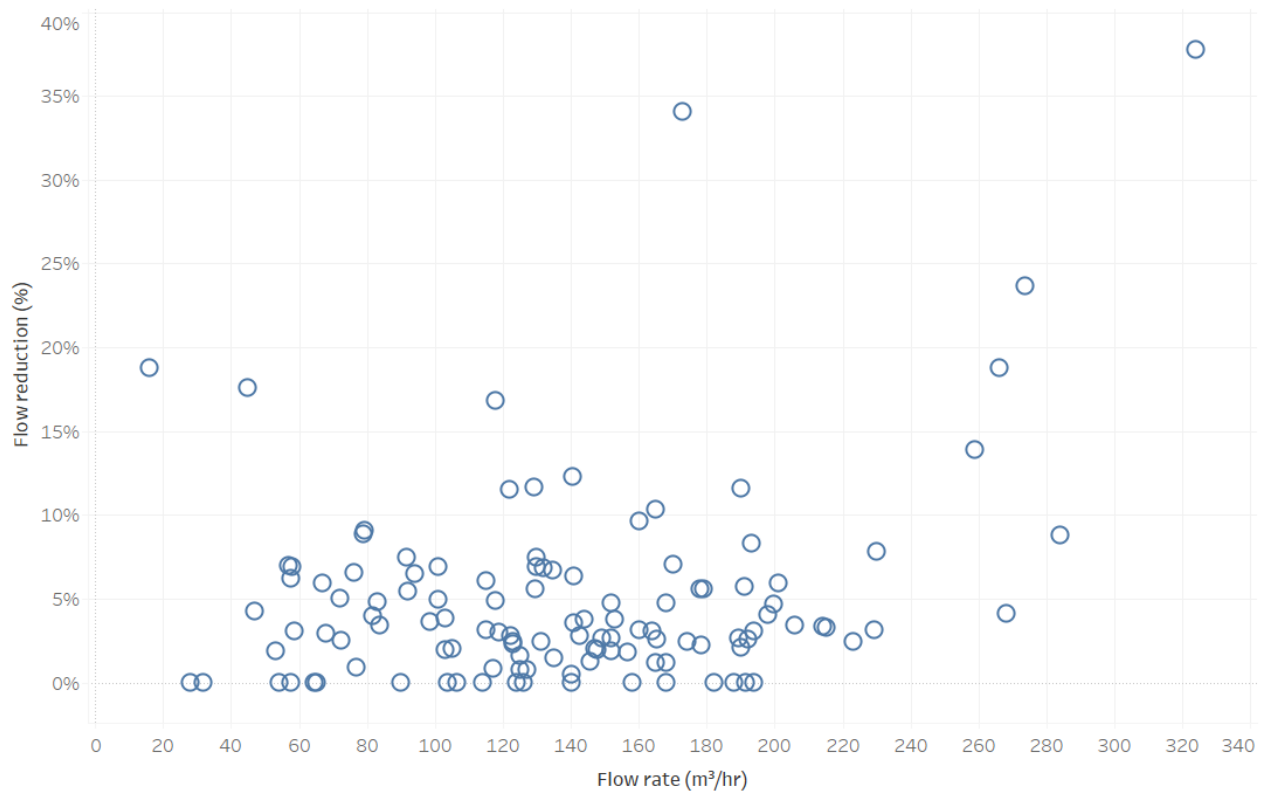
**Figure 35 Measured flow rates and flow reductions from closed door**

It is possible that higher flow rates may be more strongly affected by closed doors. Figure 35 shows the measured flow rates and the flow reduction that occurred when the door was closed. It shows that the highest measured flow rate of approximately 324 m<sup>3</sup>/h was affected by 38% when the door was closed. In these cases, insufficient makeup of air will result in reduced performance. For lower flow rates that may

conceivably be required by regulations such as NCC 2022 H6V3 (2) (iii), usually less than 100 m<sup>3</sup>/h or 30 L/s for a given house, the effect is quite minor.

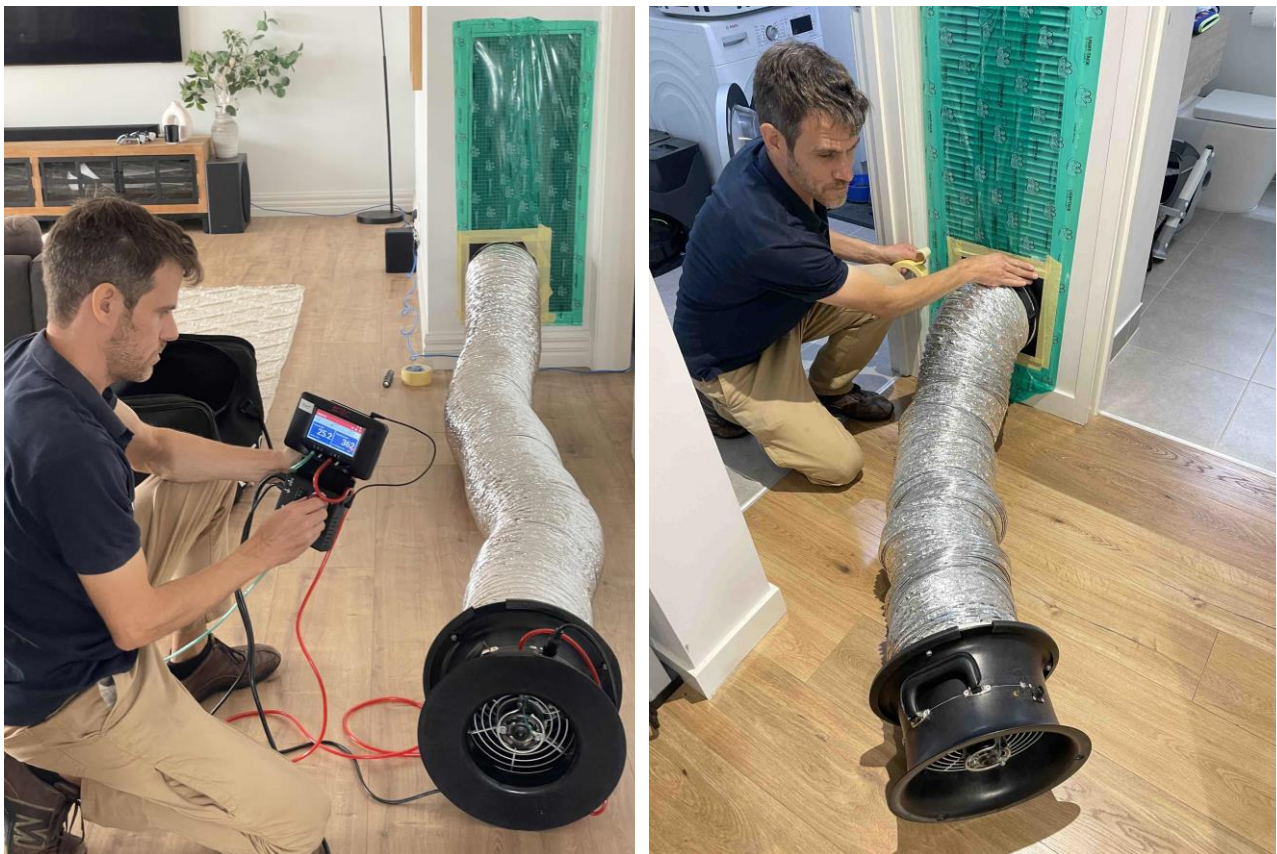
**Figure 36** Duct testing setup

The duct tester was connected to the return register with the filter removed, see Figure 36. The pressure in the ductwork was measured at the nearest supply register. After recording a baseline pressure, the ducts were then pressurised to 25 Pascals and the leakage rate recorded. The results were expressed as leakage in  $\text{m}^3/\text{h}$  at 25 Pascals.

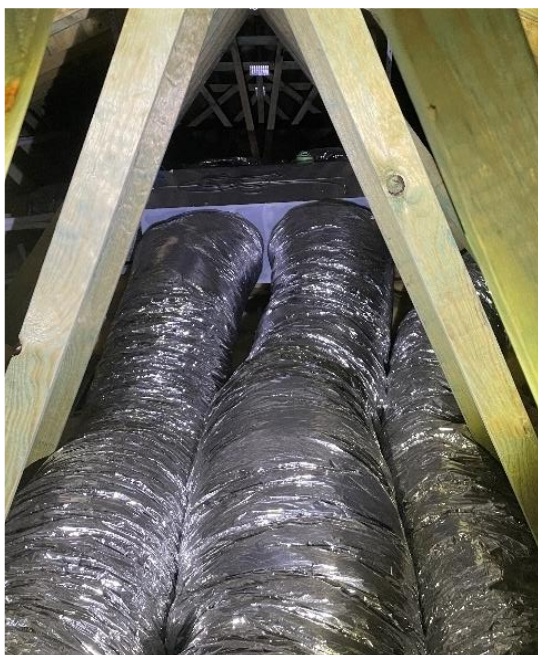
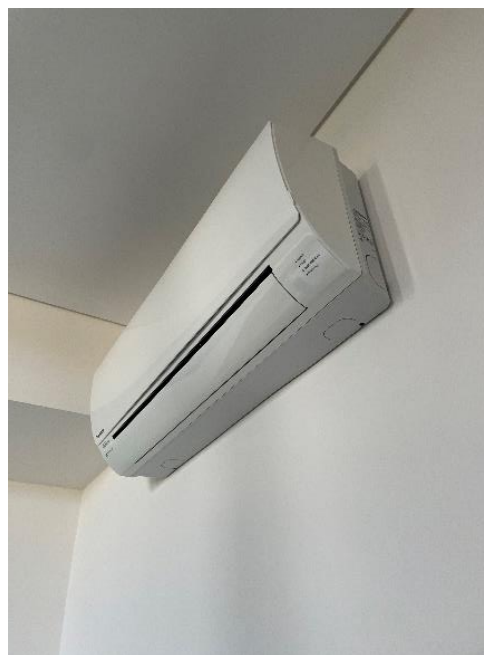
**Figure 37 Ducting distribution systems**

Any duct air leakage to an unconditioned space such as a roof space is a direct energy penalty. There is no possibility of recovering the energy spent on heating or cooling that air. However, when ductwork is located within the conditioned envelope the losses are lessened. An example is a wall surface-mounted split system. All air that passes through the system is directly recovered from the living space, and distribution losses are nil, see Figure 37.

Distribution entirely outside the conditioned envelope

Distribution entirely within the conditioned envelope

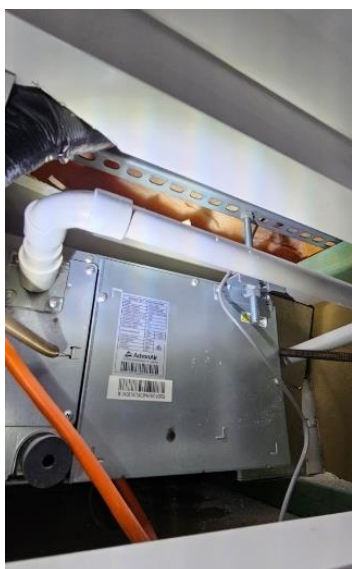
It is worth discussing the result for the bulkhead-mounted system further. Figure 38 shows the design intent. The bulkhead is meant to be located within the conditioned envelope so that any air circulated to and from the unit should remain within the thermal envelope. Unfortunately, when the registers were removed, fiberglass insulation can be seen above the unit but only partially enclosed by plasterboard. The separation between “inside” and “outside” is not well executed.

Insulation visible above unit, showing poor isolation

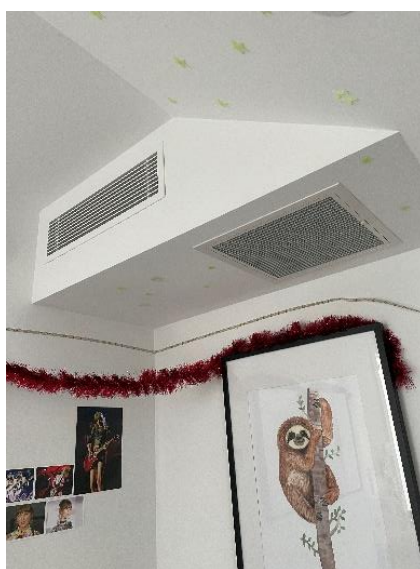
Figure 38 Poor isolation examples

Bulkhead over bed, where dust collected during testing

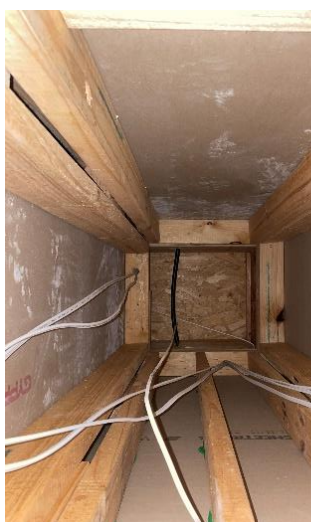
In another house, even a relatively well-sealed building cavity return contained copious rodent droppings and insect carcasses (Figure 39). In a two-storey house with especially bad leakage rate, the cavity return was being used as a general passage for many electrical and plumbing services. As a result, during the duct test, air could be felt from doorways, wall skirting, and even plumbing penetrations several rooms away, see Figure 39.

Building cavity leading to second floor

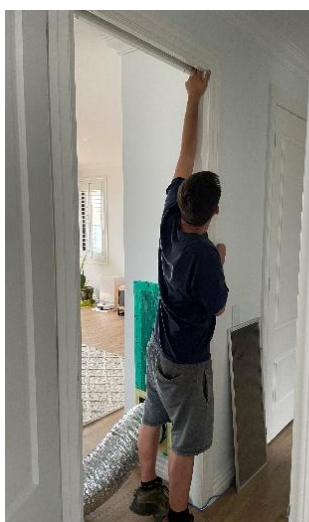
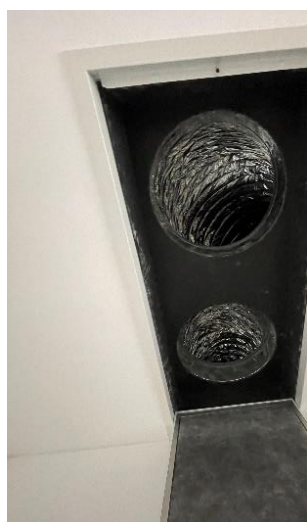
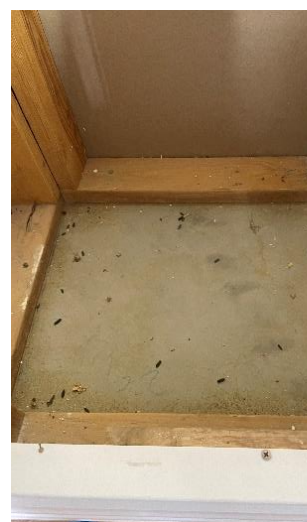
**Figure 39 Ducting issues**

During testing, air could be felt from areas not considered "ductwork"

Systems with a ducted return generally performed better

Dead insects and mouse droppings in the return cavity on another building

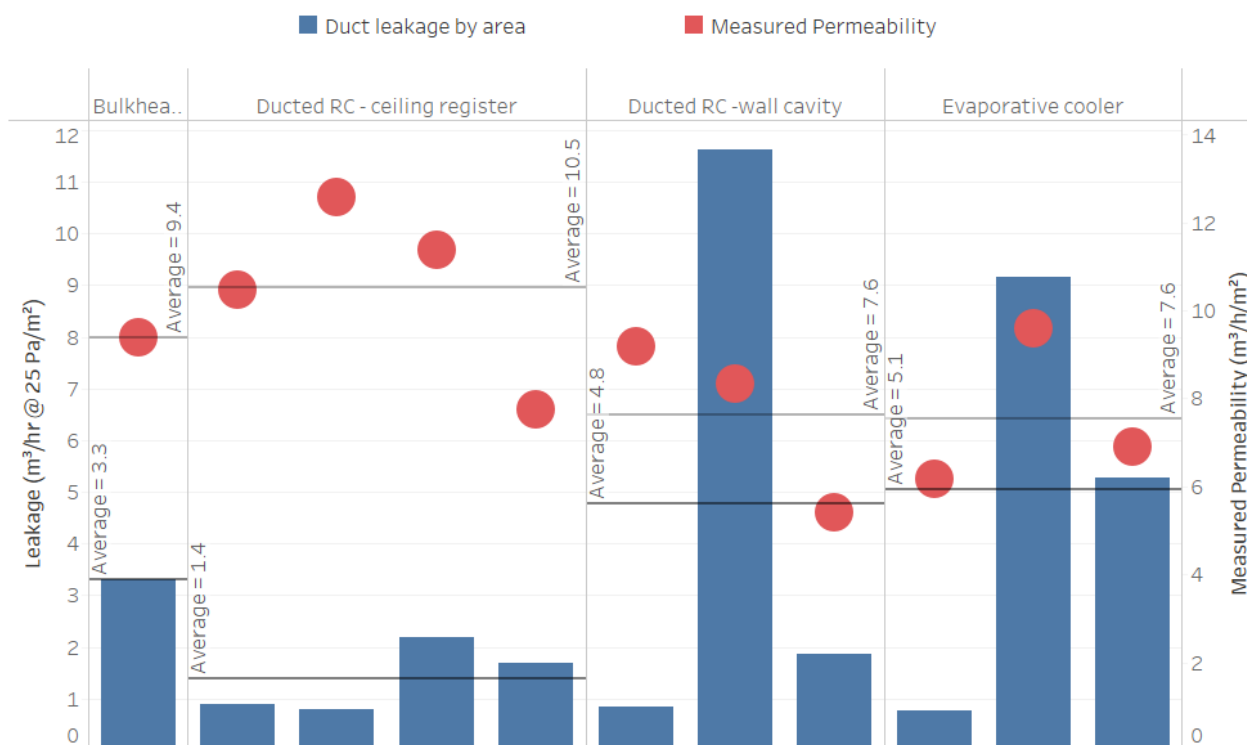
Figure 40 Duct leakage compared to dwelling permeability by HVAC system

Figure 40 compares the duct leakage results to the overall permeability results for the dwellings where duct leakage was measured. Interestingly, it shows that no obvious relationship exists between the duct leakage rates and the permeability of the dwelling. The ducted systems with the lowest average leakage rate (ducted RC with ceiling registers) also recorded the highest average permeability rate. Dwellings with ducted RC with wall cavity returns or ducted evaporative coolers had similar average duct leakage rates and identical permeability rates. The number of systems tested was only small and so caution is needed in drawing any conclusions from these results. However, it does show that well installed ducted systems of any type tested here can perform well and have low leakage rates.

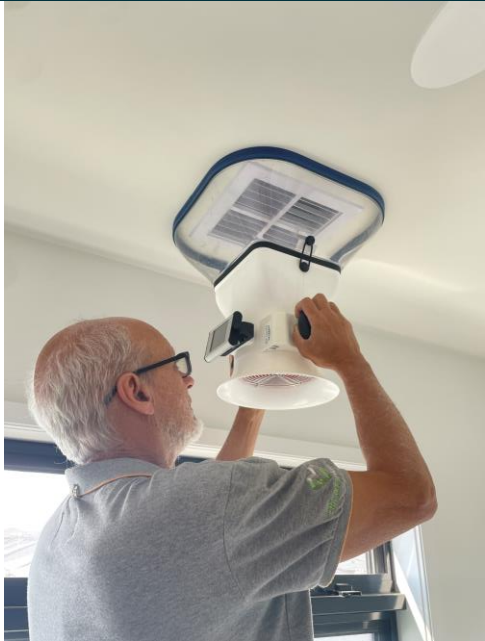
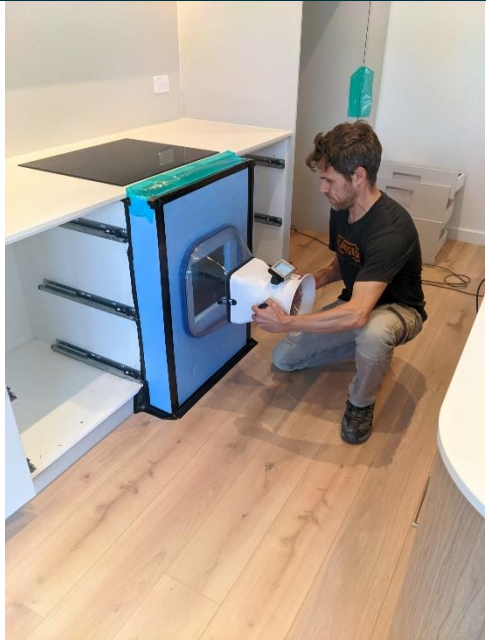
**Figure 41** Examples of methods for undertaking individual component leakage testing

| Direct measurement with flow meter | Measurement with flow meter and additional capture hood |

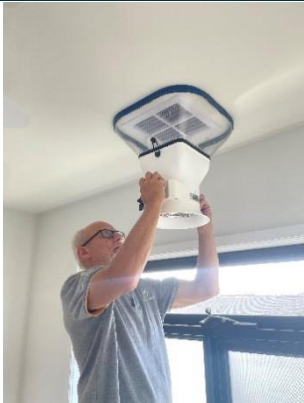
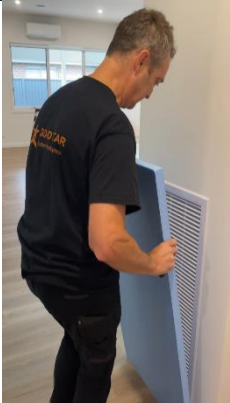
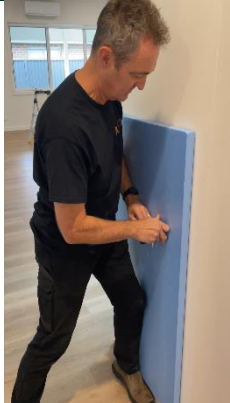
Figure 42 Measurement techniques for ducted systems

Two houses were fitted with evaporative cooling systems that were paired with separate ducted heating systems. Leakage from the systems were measured at each individual distribution register (Figure 42). For the cooling systems, it could not be confirmed whether the systems possessed dampers meant to close when the systems are not in operation. It is possible that they possessed weighted dampers and that these pulled open during testing with the house under negative pressure. Therefore, it is possible that in normal building operation, these systems do not leak as much. If not, these were by far the single largest leak in the study. Remediation would require the use of better dampers, ideally motorised so that they are not subject to opening by breezes.

| Measuring flow rate of duct system leakage from an individual register | Measuring flow rate of return duct building cavity using subtractive method with a blower door | |

In one case, a return for an air source heat pump system was made from a building cavity and the flow was too great to be measured directly with the flow hood. A subtractive method with a blower door was used. First, a blower door test was done with the ducts as they were found. Next, the duct was sealed with foam board and the test was repeated, see Figure 42. The difference between the first and second measurements can be attributed to the duct leak. There are drawbacks to this approach, including the imprecision of the blower door measurement which increases uncertainty. Also, slight changes to duct pressures elsewhere in the system during masking may reduce the scale of the measured difference, so the figure may be a slight underestimate. Still, the technique lends an approximation to an otherwise unknown value.

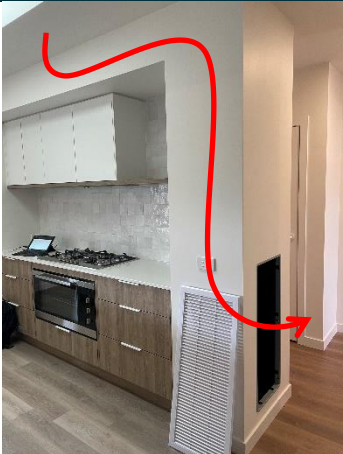
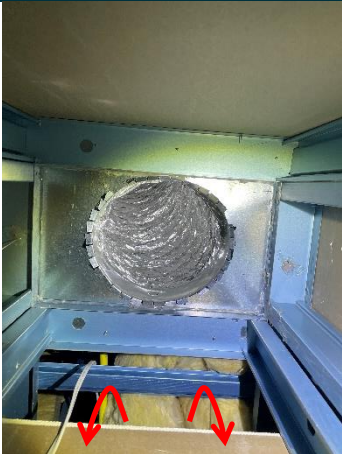
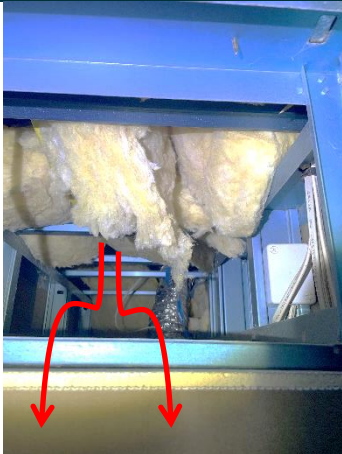
**Figure 43** The use of building cavities as ductwork

| <p>Building cavity as AC return, register removed. Pathway for air leakage from roof space is shown with arrow.</p> | <p>Looking up towards roof inside return cavity. Ceiling insulation can be seen.</p> | <p>Ceiling insulation above range hood duct in bulkhead over cabinets. Duct from range hood visible.</p> |

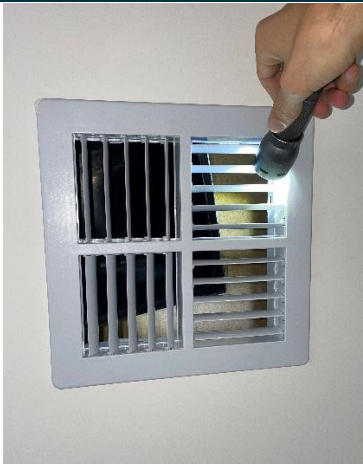
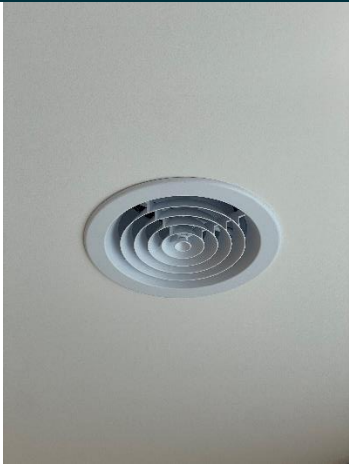
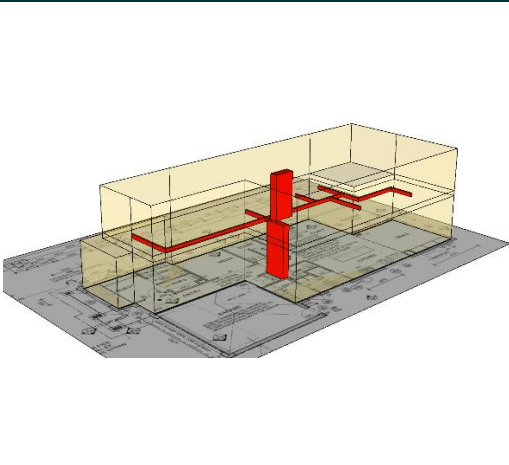
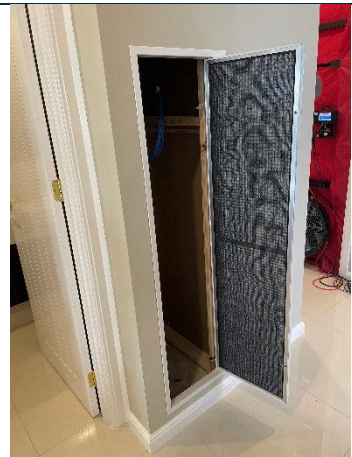
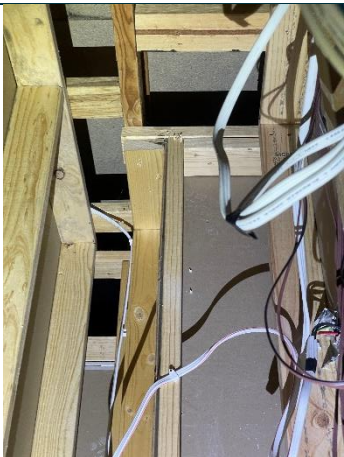
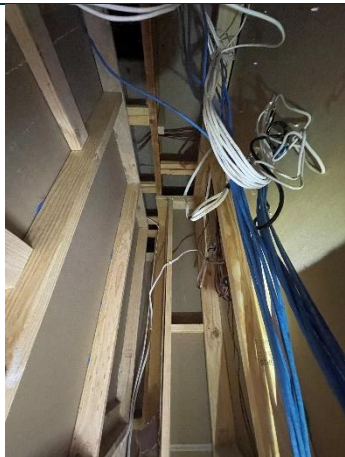
**Figure 44** Examples of building cavities being used as ductwork

| Register not connected to interior finish | Register well sealed to interior finish | Building cavities functioning as ductwork in a two-story home |
| Building cavity as return | View into building cavity return | Cavity is connected to floor assemblies and level above |

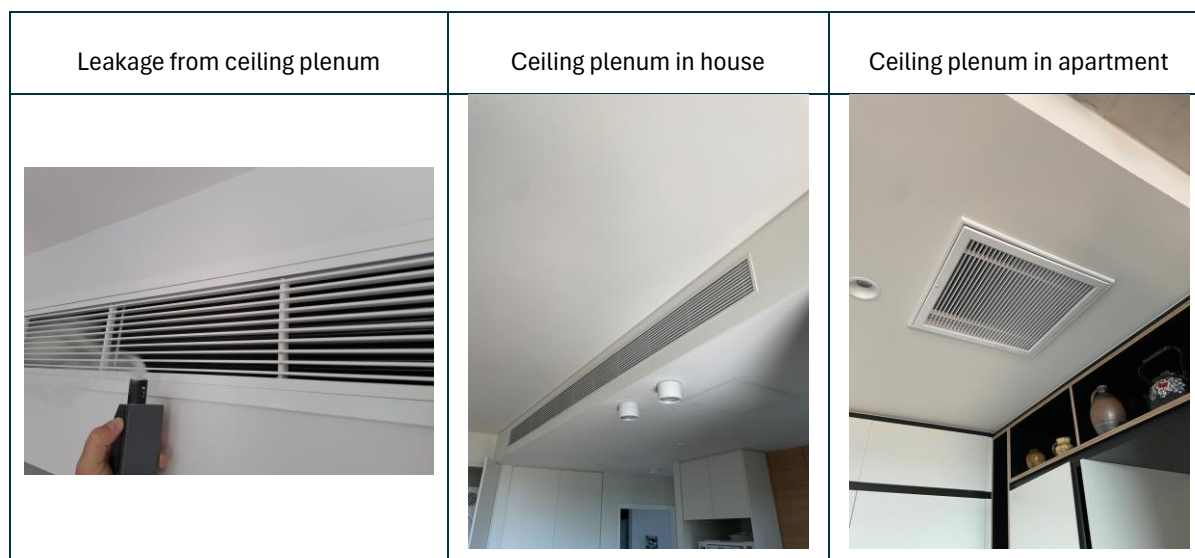
Figure 45 Ceiling plenums

From the larger study there were many examples of leaks that would be valuable to quantify if given the opportunity, such as leaks from ceiling plenums that are common in premium apartments and houses (Figure 45). There are many systems that are based on a design of using a building cavity as ductwork, with bulkhead units among them. These demonstrated major flow rates of air leakage.

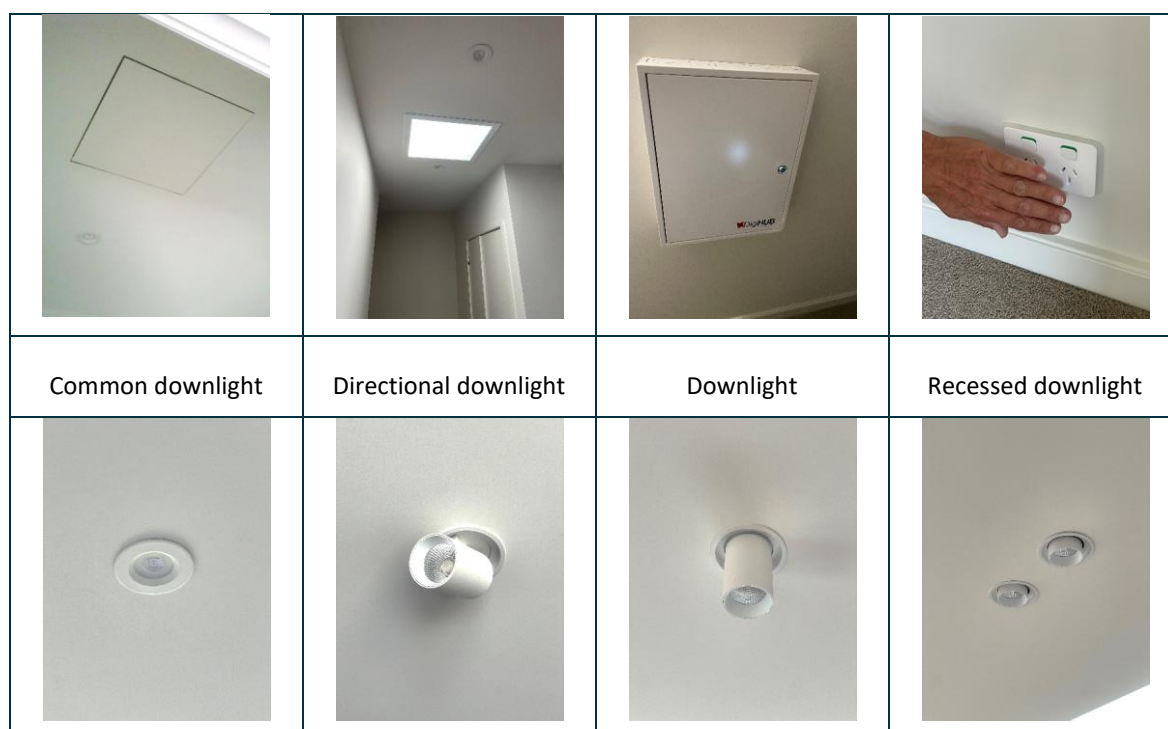
**Figure 46** Examples of individual items measured directly by flow hood

| Roof access hatch | Solar tube | Communications box | Power point |

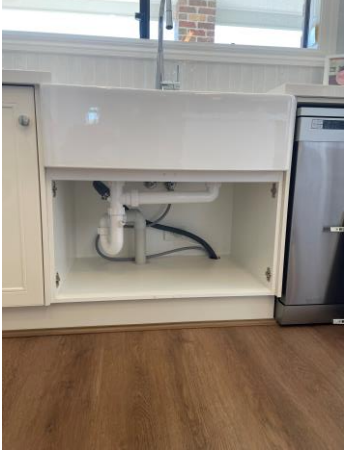
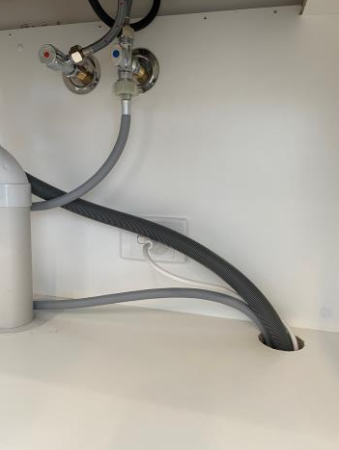
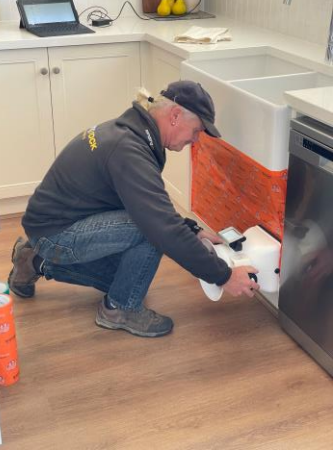
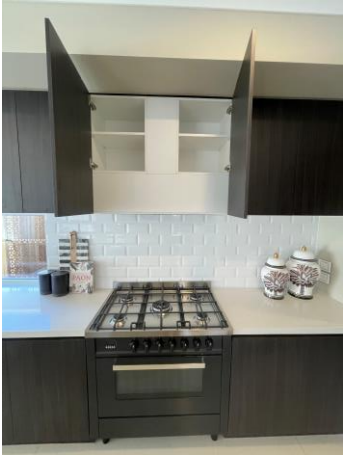
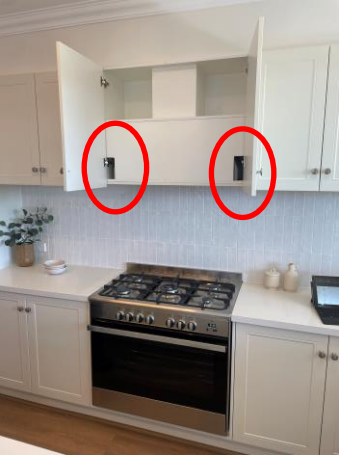
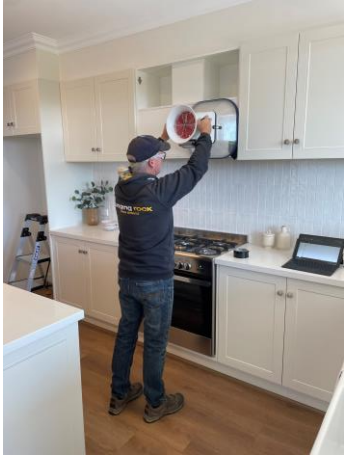
Figure 47 Examples of leaks via kitchen cabinetry

| <p>Kitchen utilities under sink</p> | <p>Variety of services</p> | <p>Sealing over cabinet and measuring with flow hood</p> |
| <p>Cabinet around range hood – no leaks</p> | <p>Cabinet around range hood</p> | <p>Measuring leak at holes for door hinges</p> |
| <p>Measuring leakage of cabinets around an oven</p> | <p>Observing leakage of cabinets around an oven</p> | <p>No solid blocking behind cabinets in another building in the main study. Plastic bags could be sucked from the cabinets into the roof.</p> |

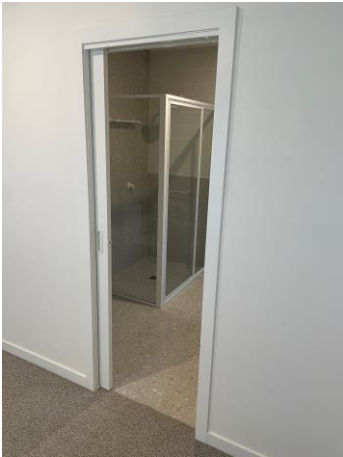
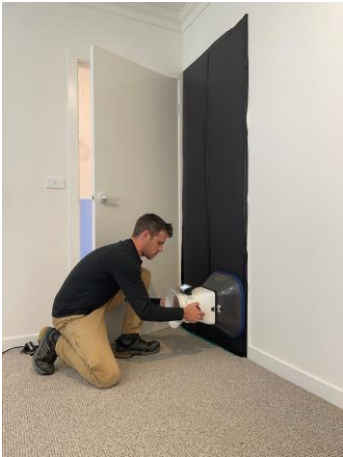
Figure 48 Leakage from cavity sliding doors

| Typical cavity sliding door | Leakage from a door strong enough to push it out of the wall | Measuring leakage from the unit with masking to capture flow |

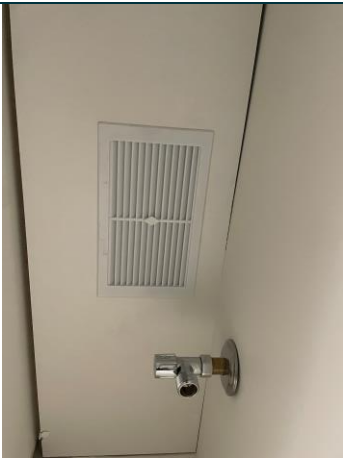
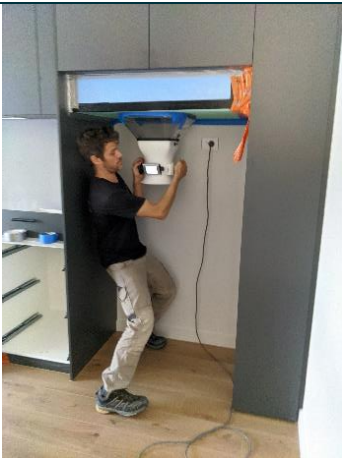
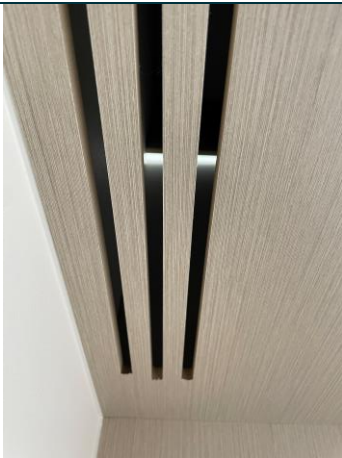
**Figure 49** Ventilation holes for refrigerator

| Vent over fridge in this sample | Custom capture hood to measure leakage from fridge vent | Large vent cut into cabinets over fridge from home in main study |

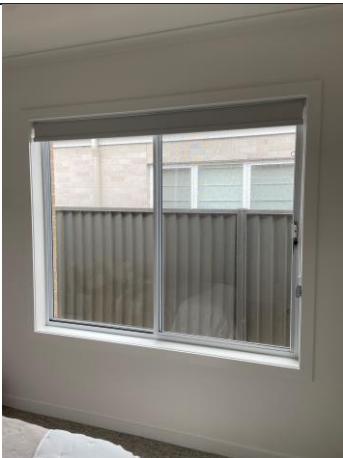
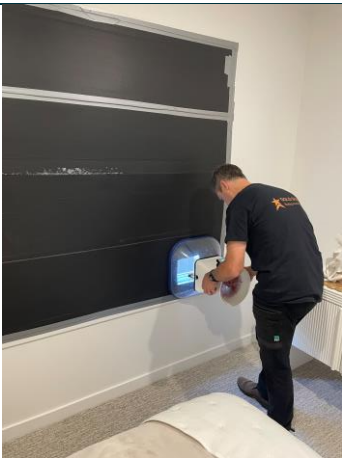
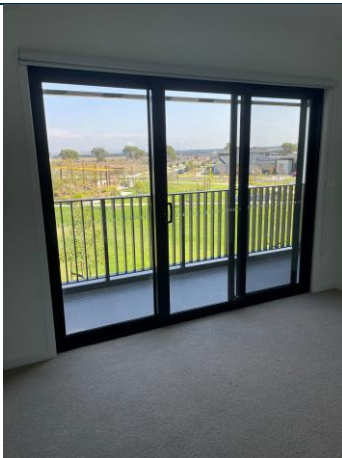
**Figure 50** Leakage from window and door units

| Casement sliding window | Masking and measuring flow from window installation | Sliding doors, not tested |
