# Air Infiltration of New Dwellings in Australia

Michael Ambrose and Sean Maxwell

June 2024

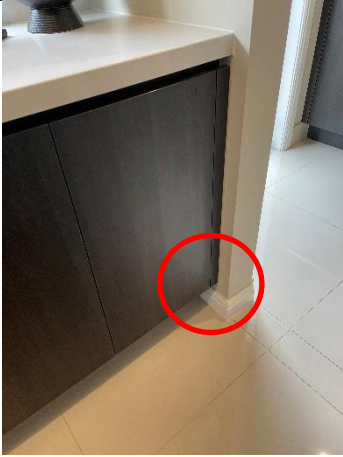
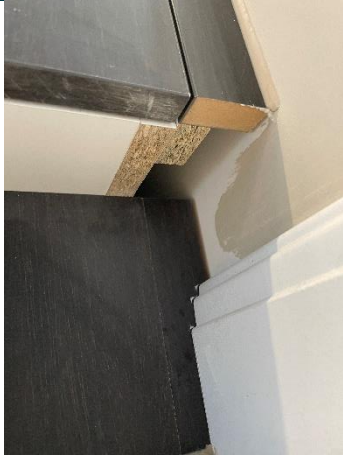
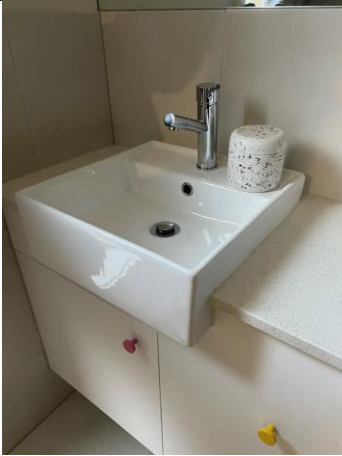
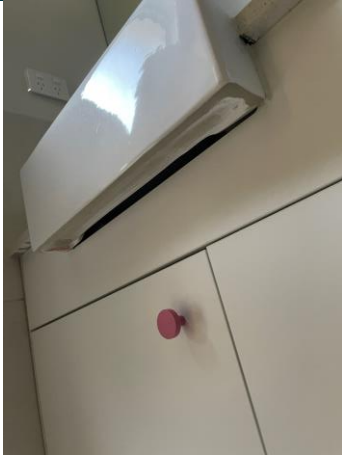
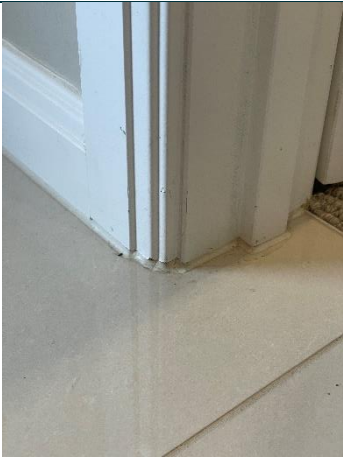
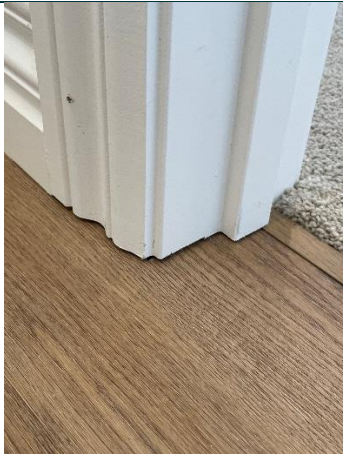
Figure 51 Examples of leakage points identified, but too difficult to measure

| Kitchen cabinet | Gap at corner of cabinet | Bedroom cabinet |
| Bathroom cabinet with leak that could not be easily measured | | |
| Skirting in one house with seal to floor | Skirting in house next door with no seal to floor | A door leak, not measured. |
| Leakage along base of wall | Leakage along skirting | Gap was not sealed before carpet was installed |
