Centre for Sustainable Architecture with Wood

Comparison of Test Cell Thermal Performance & The Empirical Validation of AccuRate in a Cool Temperate Climate

FWPRDC project PN04.1009

Final Report

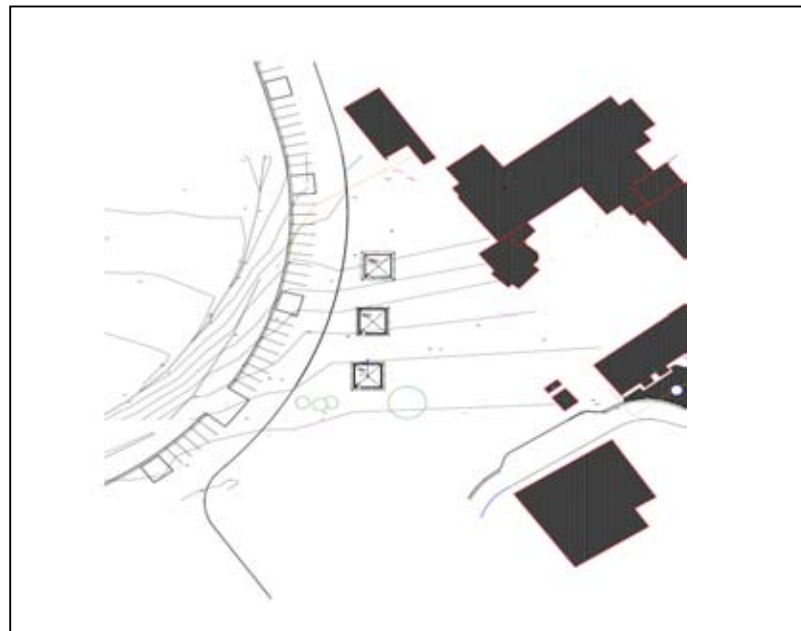
Figure 3: Site Plan of the Test Cells

- a car park and sports oval to the west;
- well established trees to the south;
- open grass and distant buildings, about 30m - 60m to the east; and
- open grass and distant buildings, about 13m-25m to the north.

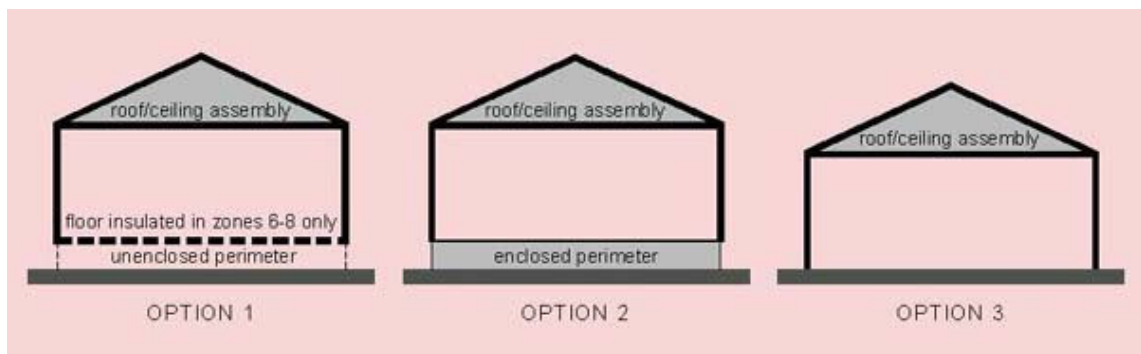
Figure 5: Standard Housing Floor Systems (ABCB., 2005)

The BCA lists three standard types of flooring options for residential construction. As shown in Figure 5, these are the unenclosed perimeter platform floor, enclosed perimeter platform floor and slab-on-ground floor.

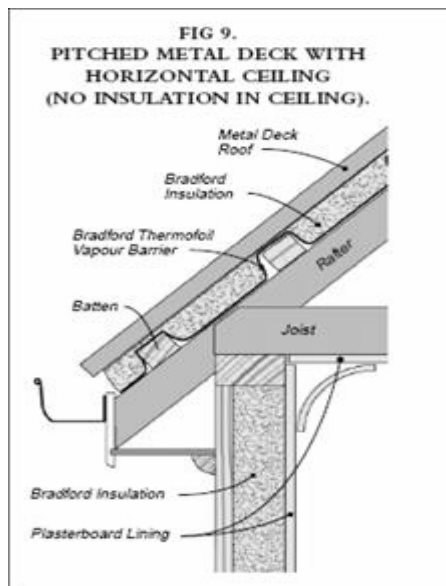
Figure 6: Typical detail of sarking based on The CSR Bradford Building Design Guide

- For reflective foil sarking to work effectively, it requires a no contact air gap between the roofing material and the foil sarking. This is normally achieved by draping the sarking loosely over the battens. However, it has been observed in actual practice that the foil sarking is often being pulled tight for ease of installation. This creates a thermal bridge and counters the insulating effect of the sarking. Hence, it was decided to lay the sarking over the rafters and lay the battens on top of the sarking. This guaranteed a batten depth gap between the sheet metal roofing and the sarking.

- The second difference to standard construction practise in the roof was the taping of the sarking at joints. Standard practise requires a 150mm overlap at joints in the sarking. This allows air movement in the general roof space and the cavity of the sheet metal roofing and sarking. In this project, however, the roof sarking was taped for the purpose of examining best building practise and to reduce performance variables.

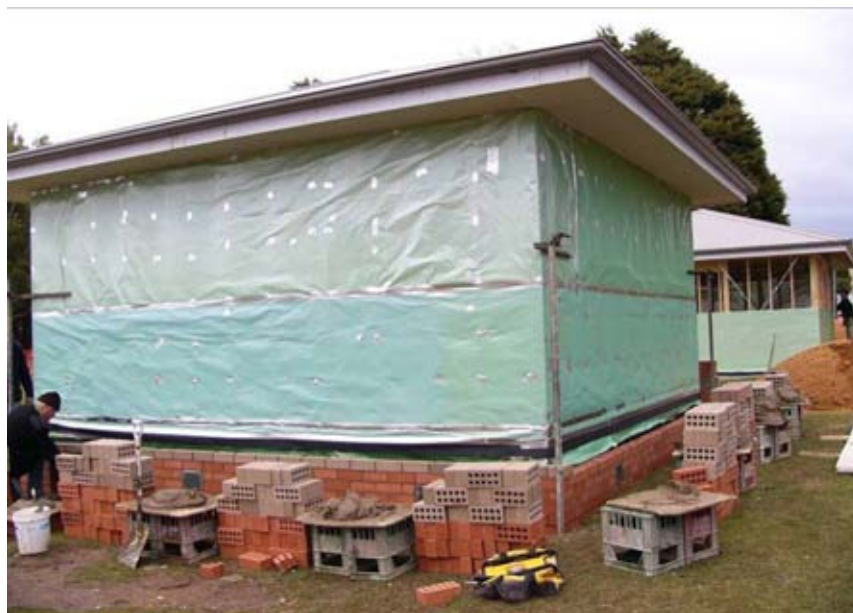
Figure 7: Taped and patched building wrap

In the roof space, the application of the building wrap to the walls was considered at length. Standard installation practice provides a 150mm overlap between sheets and this is applied to the structure with steel staples. Common faults with this form of application include the puncturing of the wrap and the provision of air movement between the cavity air space and the outside face of the plasterboard lining. To eliminate this possible variable and to display best construction practise the building wrap was taped at joints. At the same time any punctures in the building wrap were also taped (See Figure 7).

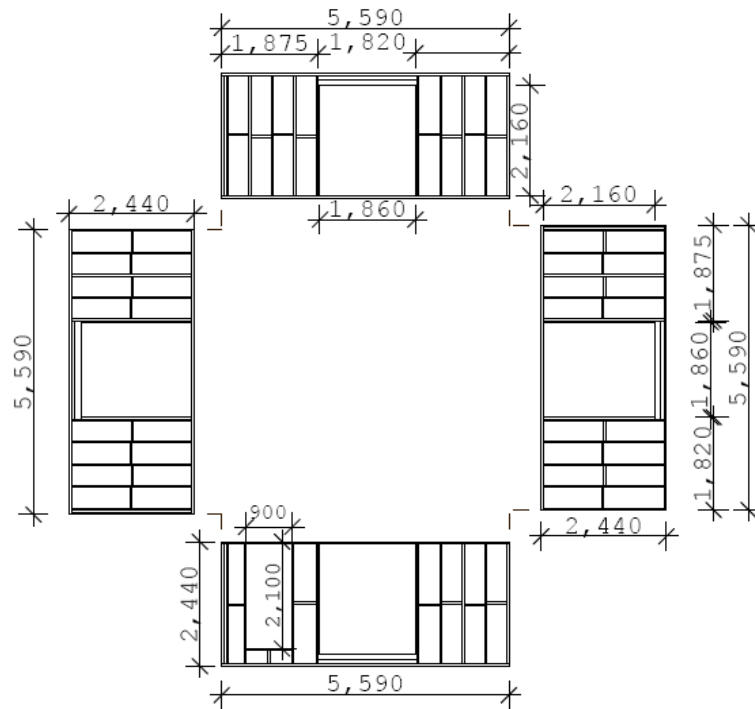
Figure 8: Test Cell Framing Plan

The wall framing has an integrated provision for the eventual addition of windows on each face of the building. This required the inclusion of framing within the standard stud work of the wall panel to allow a future 1800 wide full height opening to be made without alteration to the structural frame. Figure 8 shows the framing plan for the test cells while Figure 9 shows the framing as built for Test Cell 2.

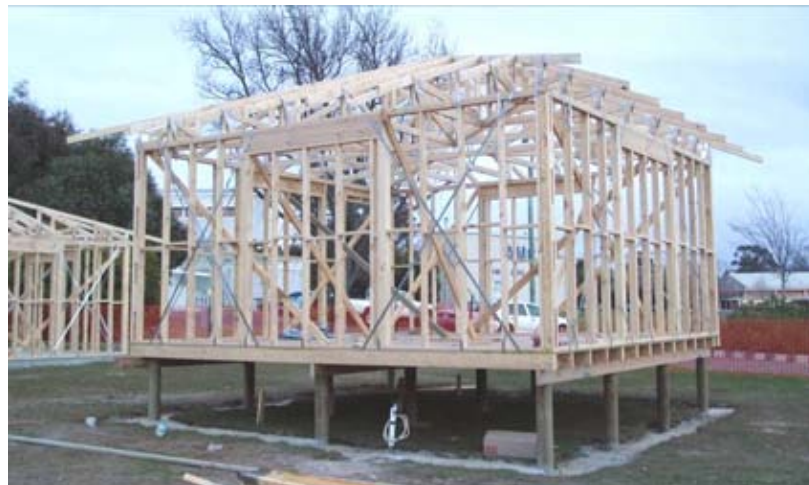
Figure 9: Test Cell 2 Wall and Roof Framing

The provision for future windows and current timber framing practises increased the framing factor of the wall from 12.3% to 18.3% compared to the conventional. The framing factor is the percentage of timber in the elevation of the wall. While timber is a better insulator than steel, it is not as good an insulator as bulk insulation and the greater the area of timber in a wall, the

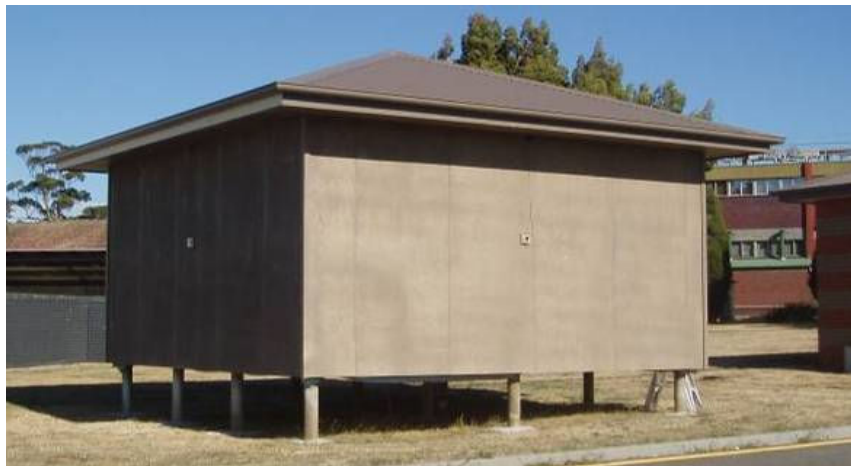
Figure 10: Test Cell 1 – Western View

Test Cell 1 is an unenclosed perimeter platform floored building (See Figure 10). The building sits on timber poles, is timber framed with plywood cladding and has a sheet metal roof.

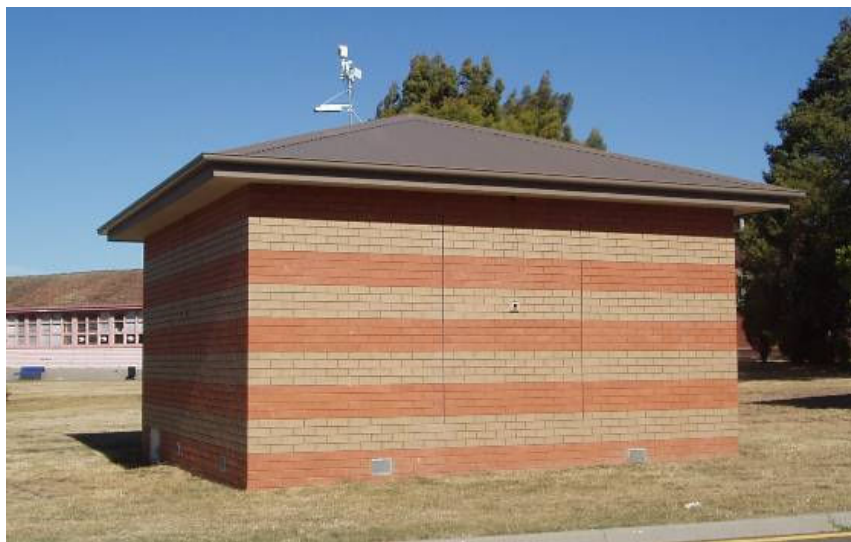
Figure 11: Test Cell 2 – Western View

Test Cell 2 is an enclosed perimeter platform floored building (See Figure 11). The building sits on poles but has a brick veneer cladding that extends to the ground plane. There are vent holes in the sub floor brick work to allow for ventilation. Test cell 2 also has a sheet metal roof.

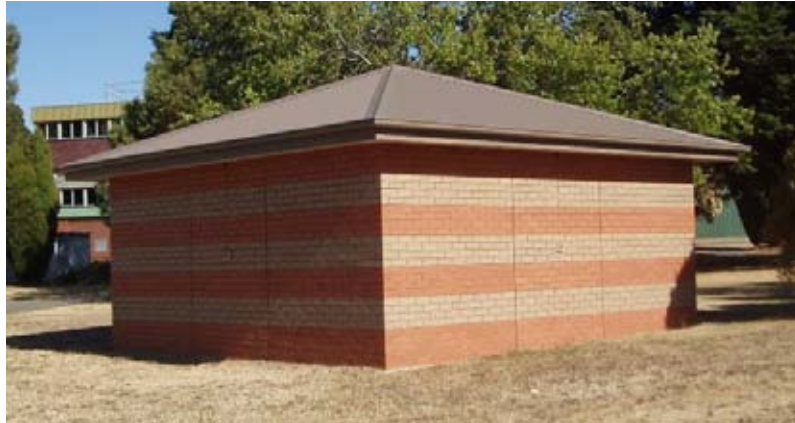
Figure 12: Test Cell 3 – Western View

Test Cell 3 is a concrete slab on ground floored building (See Figure 12). The building sits on its concrete slab and has a brick veneer cladding that extends to the ground plane. Test cell 3 also has a sheet metal roof.

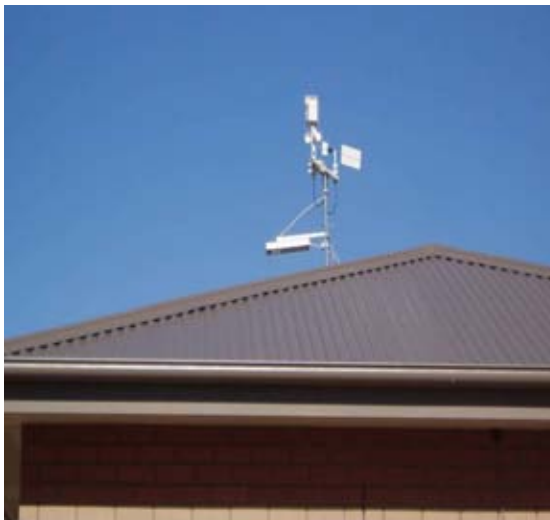
Figure 17: On-Site Weather Station

For the purpose of empirical validation, a new site-specific climate file was created based on measurements taken on a 10-minute cycle. The AccuRate climate file was modified using measured values instead of the built-in climate data for zone 26. This would essentially lead to a more reliable comparison of simulated and observed thermal performance as both are based on the same climate data.

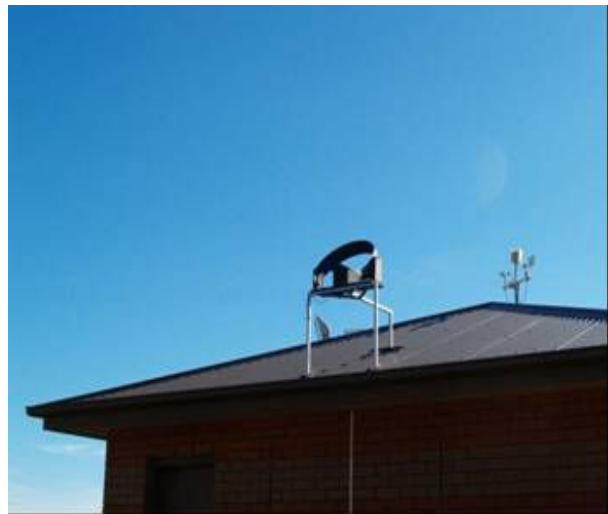
Figure 18: The diffuse solar radiation shadow ring device installed in February 2008

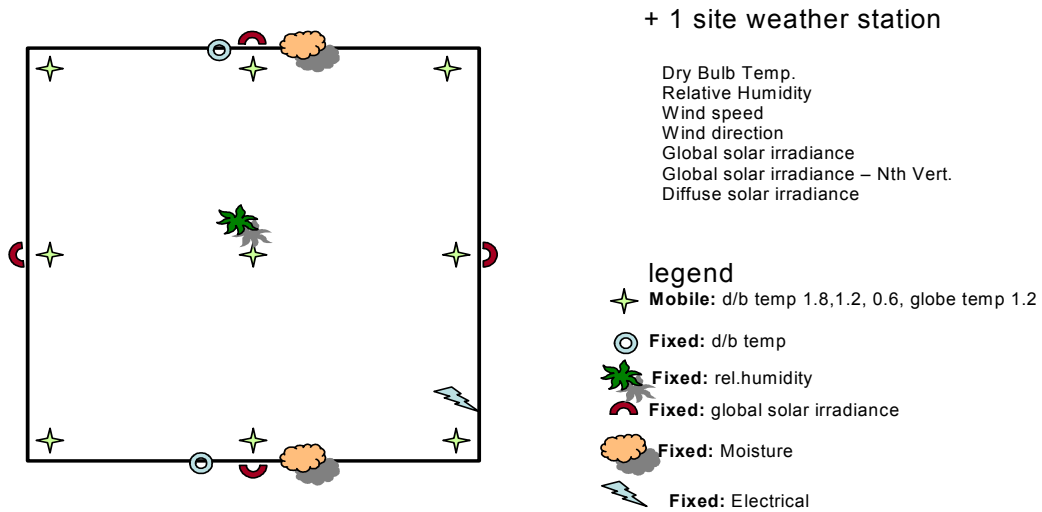
Figure 19: Monitoring Plan of the Three Test Cells

Empirical validation requires simulating each internal zone; hence each zone was fully instrumented. Measuring equipment was positioned at mid-height at the centre of each zone. Stratification and air movement in the room were monitored using additional sensors, i.e., at 600mm and 1800mm from the floor level in the test cell room. Figures 19, 20 and 21 show the monitoring plan and section of the test cells. This method differs from ASHRAE Standard 55-2004 for interior environmental measurement (ASHRAE, 2004) but is suited for the thermal performance measurement of test buildings (Lomas, 1994).

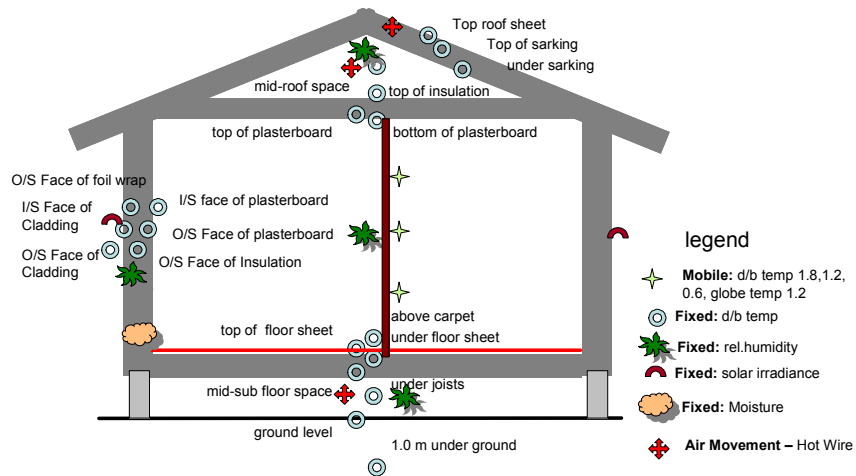
Figure 20: Monitoring Section – Platform Floor

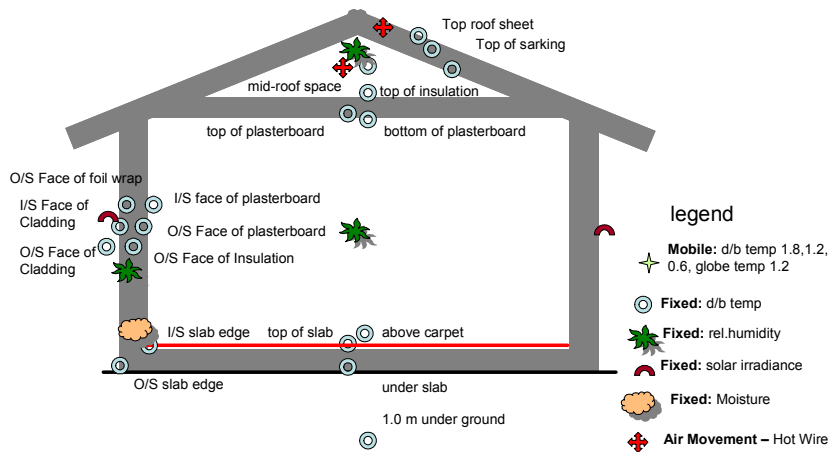
Figure 21: Monitoring Section – Slab on Ground Floor

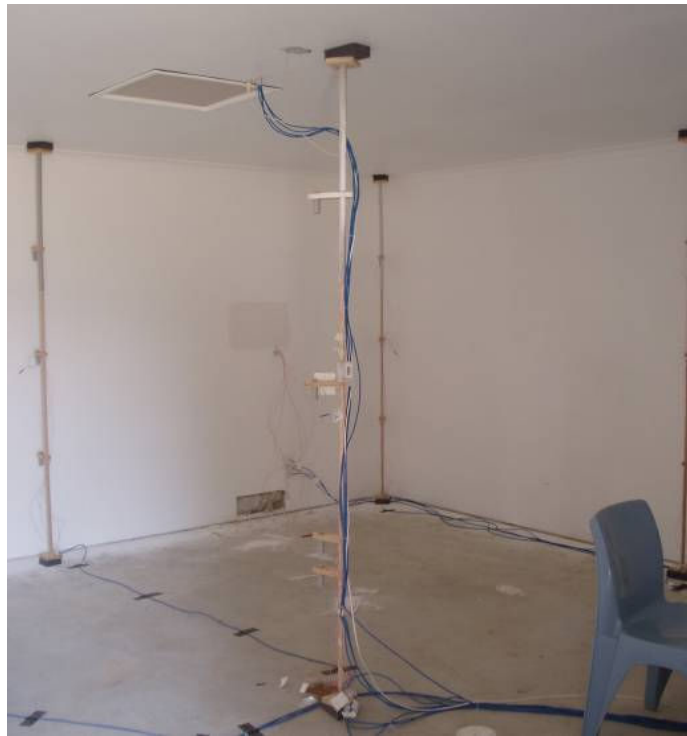
Figure 22: Sensors attached to the centre of room and edge of room poles

- Interior surface of particleboard platform floor;
- 600mm above floor (1/3 room height);
- 1200mm above floor (mid room height);
- 1800mm above floor (2/3 room height); and
- Interior surface of the plasterboard ceiling.

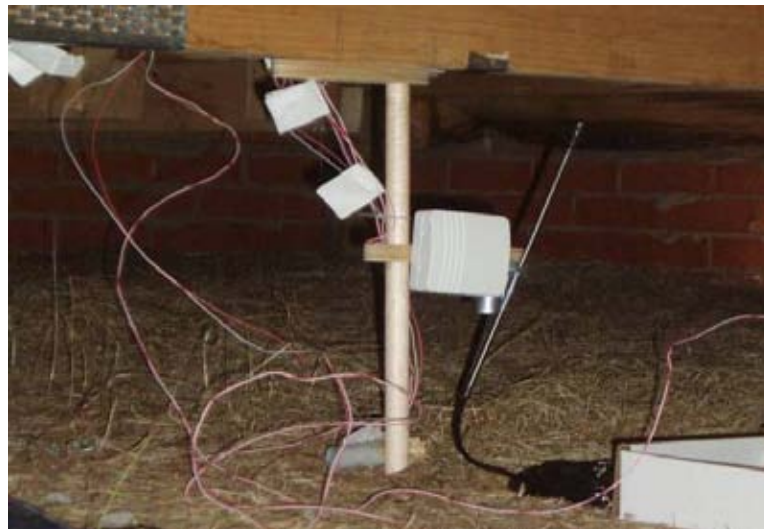
Figure 23: Sensors at the Subfloor Pole

AccuRate treats the subfloor space as a distinct zone in both the enclosed and unenclosed perimeter platform floored test cells. To measure the environmental condition in these zones, a vertical pole was installed in the centre of the space. This pole records air temperature at ground level, mid sub floor height and the outside surface of particle board flooring. A humidity sensor was also installed at mid pole height (See Figure 23).

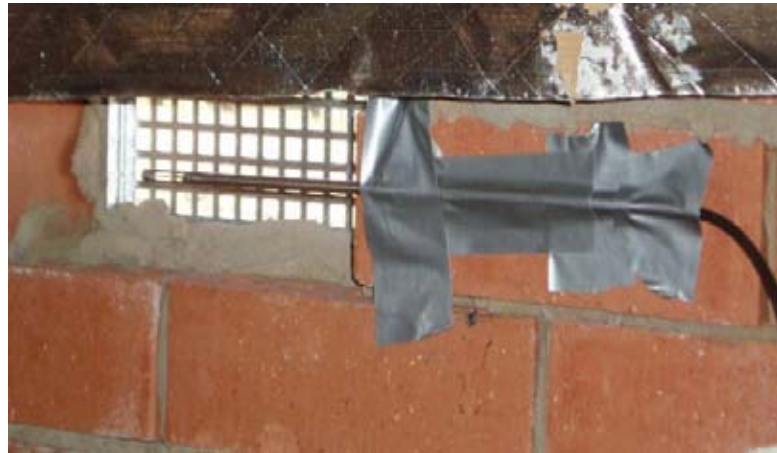
Figure 24: Hot Wire Air Speed Sensor at North Sub Floor Wall Vent

For an enclosed perimeter subfloor, AccuRate predicts the thermal condition for the enclosed perimeter sub floor zone based on the fabric matrix, ground condition and sub floor ventilation patterns. To examine this model, temperature, air movement and humidity sensors were placed in the mid subfloor area. In addition, air movement in the subfloor space was monitored by means of sensors placed in the subfloor perimeter vents as shown in Figure 24.

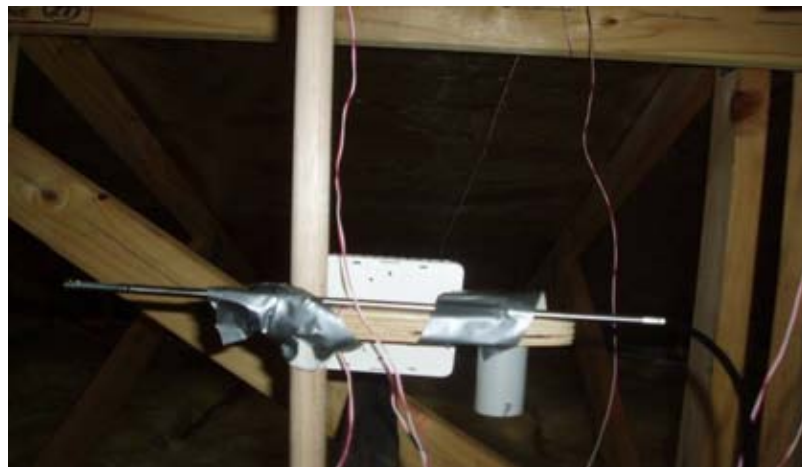
Figure 25: Roof Space Pole for Sensors

AccuRate treats the roof space as a thermally interactive zone. The simulation process predicts roofspace average hourly temperature. This is a combination of the effect of the environmental conditions on the roofing fabric matrix, the effect of the test cell room below and the rate of air infiltration in the roof space. To validate the roofspace simulation model, a sensor array was installed to measure air temperature, humidity and air movement within the roof zone. A pole with sensors placed at mid-height was placed at the centre of the roof space as shown in Figure 25.

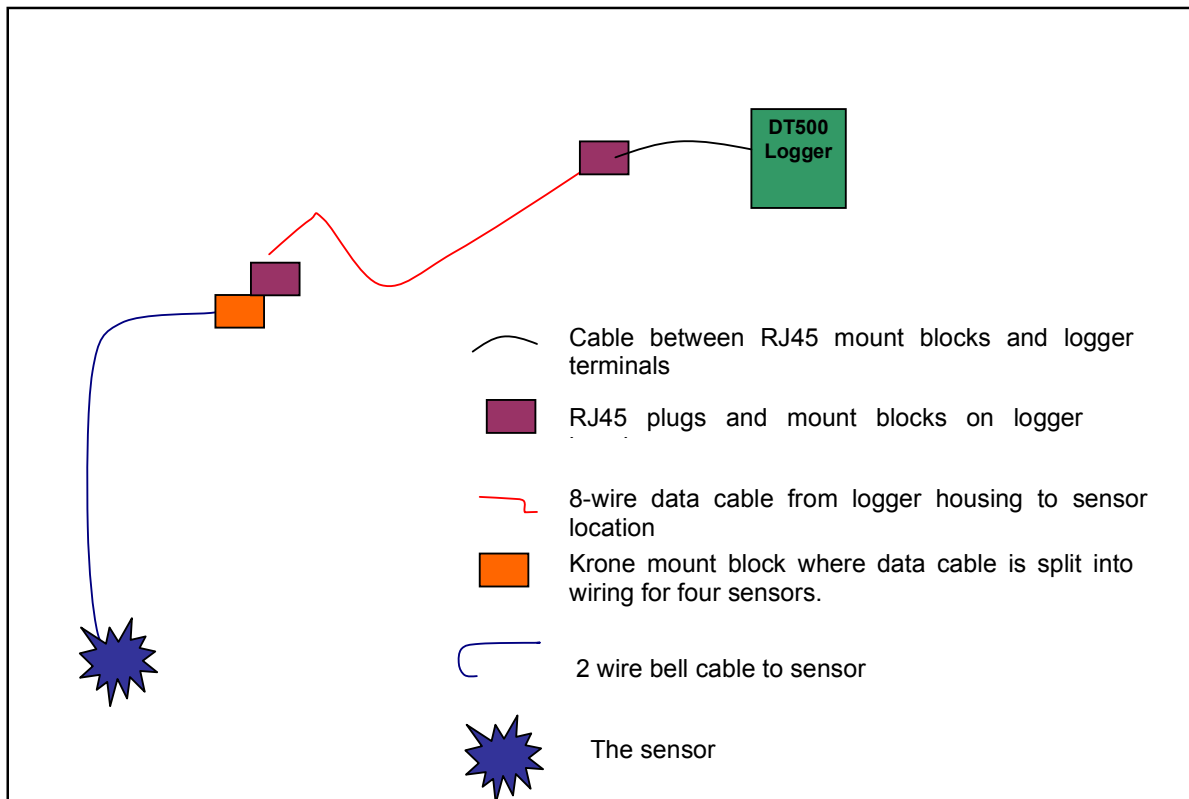
Figure 26: Diagram of Cabling System in the Test Cells

The cabling system was suited to provide a desired level of flexibility. Figures 26-30 show the cabling practice for the integrated system developed for this project. The approach allowed the location of the logger and sensor to be changed as needed. They can be placed side by side in one project and at differing ends of a house in another. A method of cable testing was developed to ensure data accuracy, preventing data anomalies noticed in the early stages of the project.

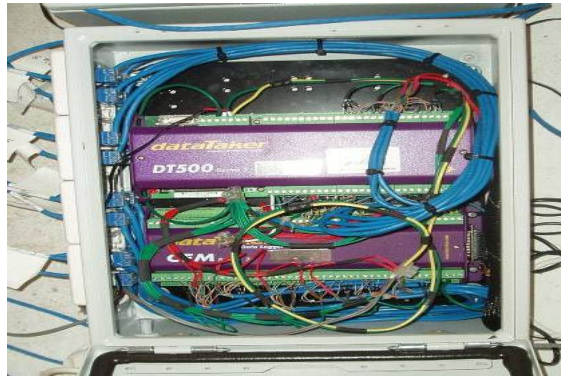
Figure 28: Cabling Practice showing Category 5 data cable, connector and 2 wire sensor connection

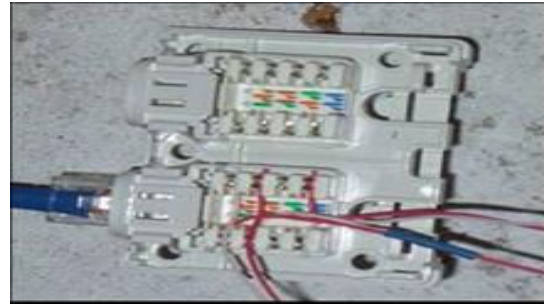
Figure 29: Cabling Practice showing RJ45 plug on outside of data logger box

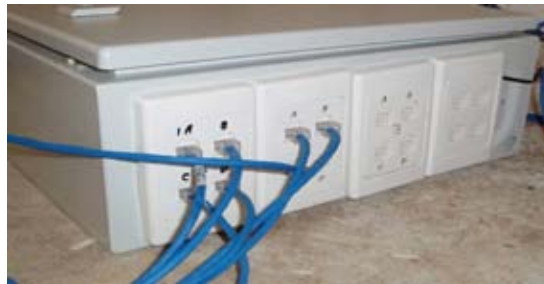
Figure 30: Cabling practice showing in-wall sensors, i.e., inside brick, outside building wrap, outside insulation, outside plasterboard surface and internal plasterboard surface

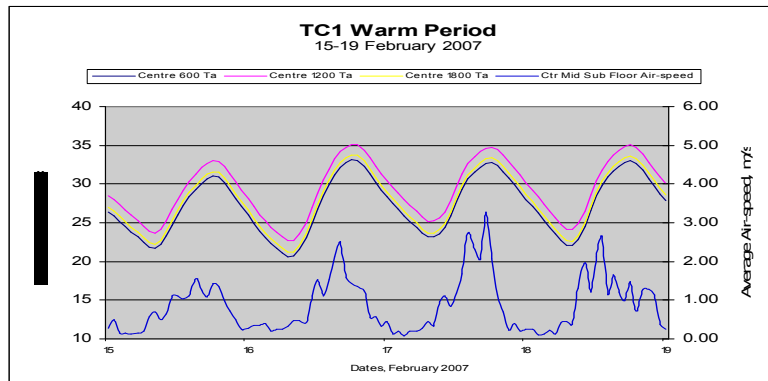
Figure 33 Test Cell 1 Room Temperature Stratification and Subfloor Airspeed during a Warm Week

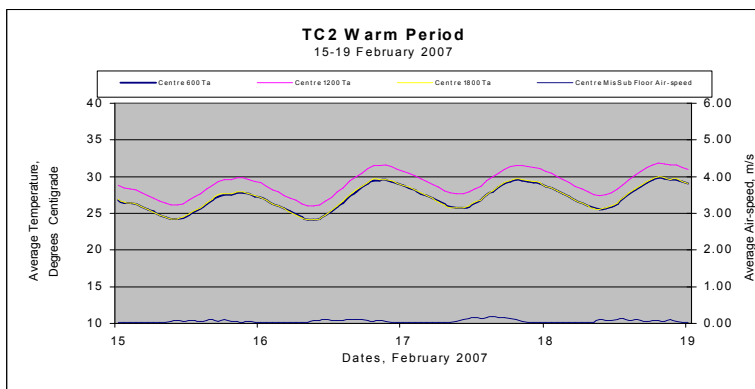
Figure 34 Test Cell 2 Room Temperature Stratification and Subfloor Airspeed during a Warm Week

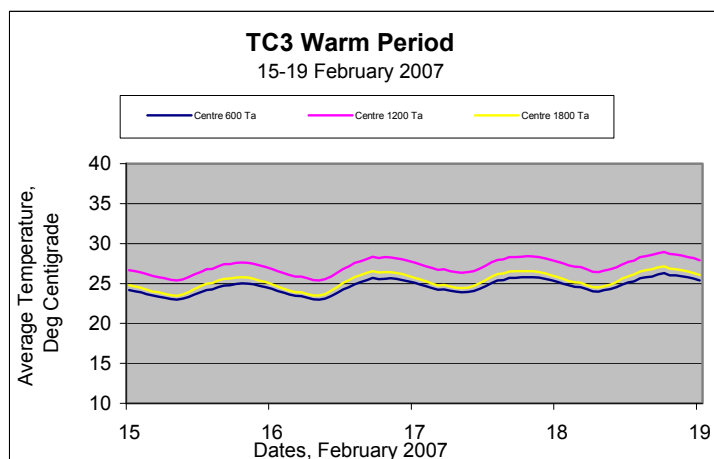
Figure 35 Test Cell 3 Room Temperature Stratification during a Warm Week

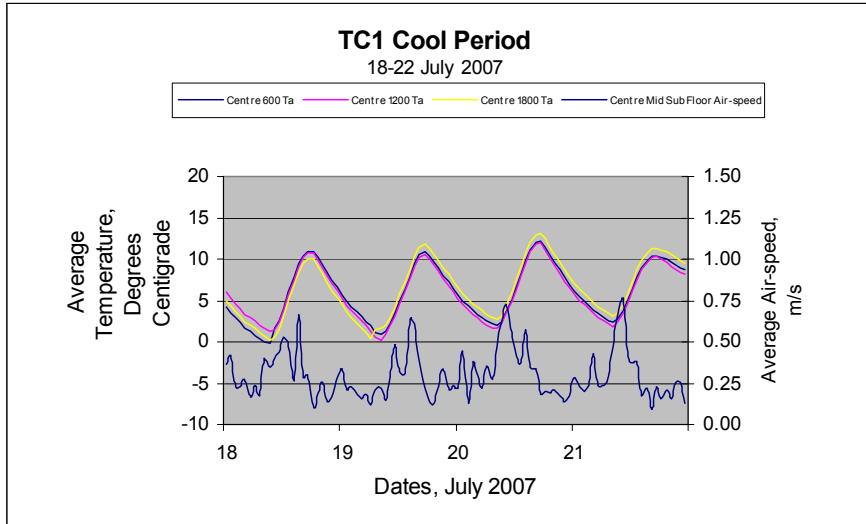
Figure 36 Test Cell 1 Room Temperature Stratification and Subfloor Airspeed during a Cool Week

During the cool period, Test Cells 2 and 3 show more consistent and distinct trends compared with Test Cell 1. In Test Cell 2, the temperature at a height near the ceiling was higher than at mid-height and near the floor. In Test Cell 3, the near ceiling and mid-height temperatures were higher than near the floor. In Test Cell 1, a consistent trend towards the end of the four-day period showed that the temperature near the ceiling was the highest whereas at mid-height, the lowest.

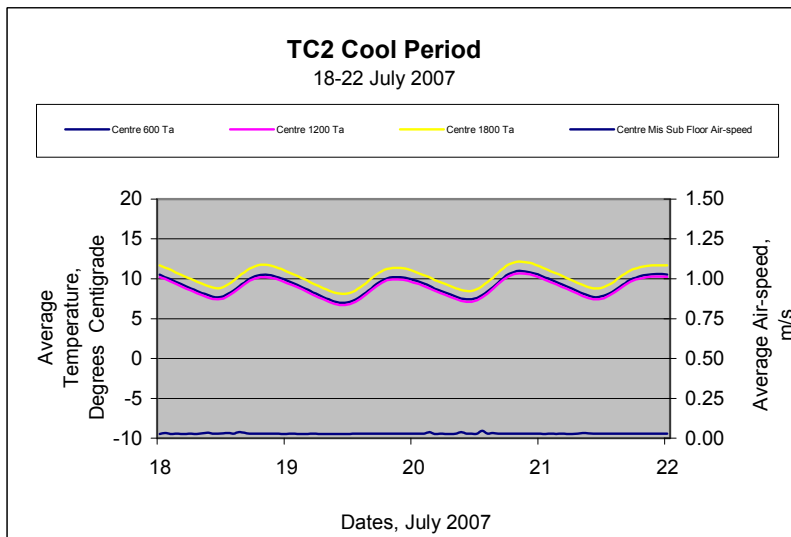
Figure 37 Test Cell 2 Room Temperature Stratification and Subfloor Airspeed during a Cool Week

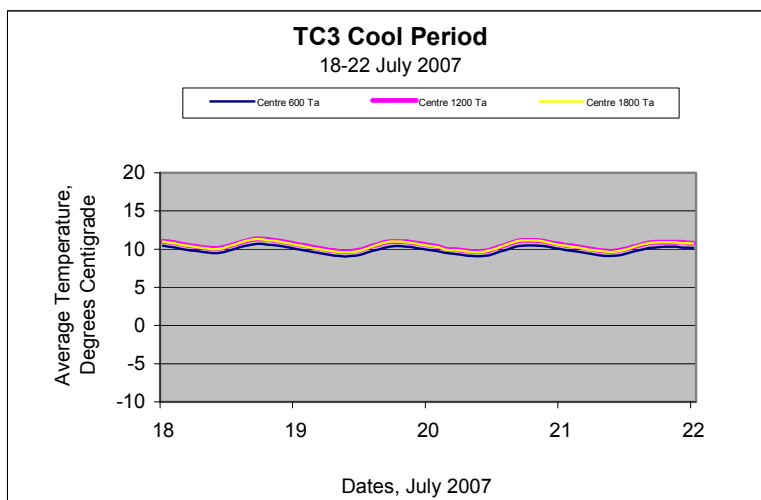
Figure 38 Test Cell 3 Room Temperature Stratification during a Cool Week

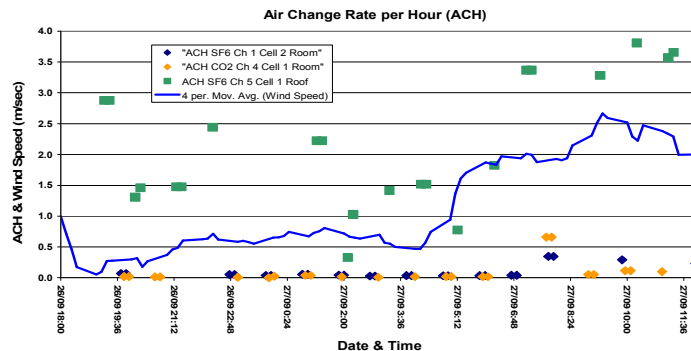
Figure 39: Wind velocity and air change rates in the rooms and roofs of Test Cell 1 and Test Cell 2

Figures 39, 40 and 41 show the wind speed and its effect on the air change rates per hour (ACH) in the roof and rooms over a two-day period. With ACH generally not exceeding 0.1, it can be said that the rooms were very airtight when the doors were shut. It was noted that measurements greater than 0.1 were instances when doors were opened such as when staff entered the room to monitor the tests. In the roof spaces, however, higher airflow was observed compared with the airflow in the rooms, with Test Cell 1 and Test Cell 3 roof spaces experiencing relatively higher airflows compared with Test Cell 2.

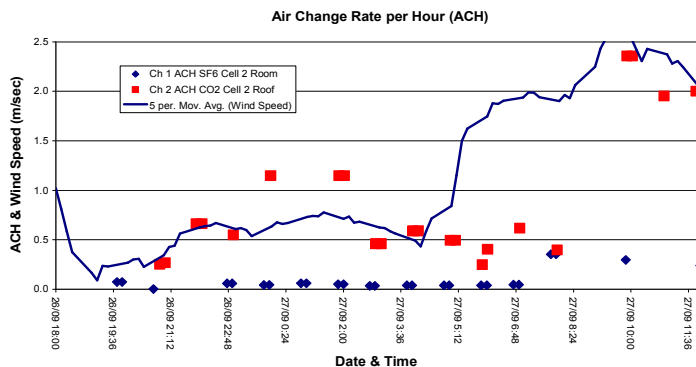
Figure 40: Wind velocity and air change rates in the rooms and roofs of Test Cell 2

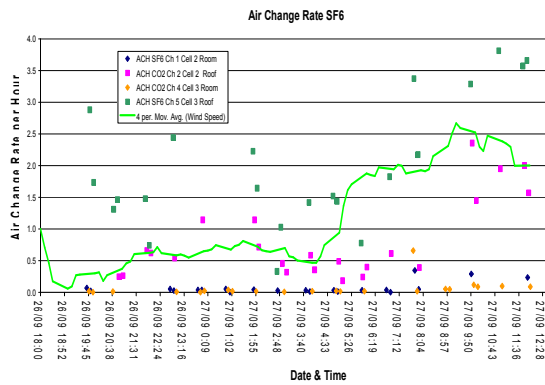
Figure 41: Wind velocity and air change rates in the rooms and roofs of Test Cell 2 and Test Cell 3

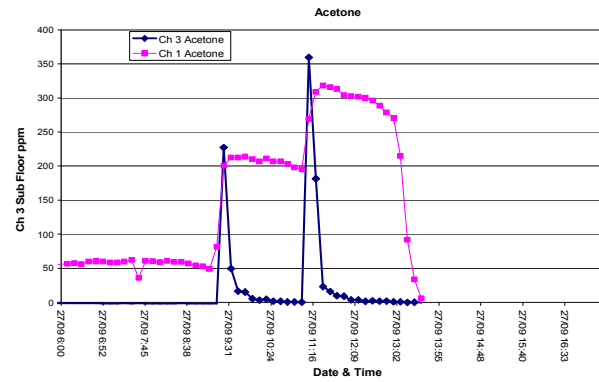
Figure 42: Volume of acetone gas migrating from the subfloor into the room in Test Cell 2

Figure 42 shows that in Test Cell 2, acetone tracer gas released in the subfloor space (Ch 3) was detected in the room (Ch 1), possibly due to leakage at the bottom plate-particleboard joint. Furthermore, the decay rate of the acetone tracer gas was significantly slower compared to its migration into the room. This could be attributed to the quality of building wrap installed in the wall cavity, which appears to have prevented the tracer gas from leaking out through the walls.

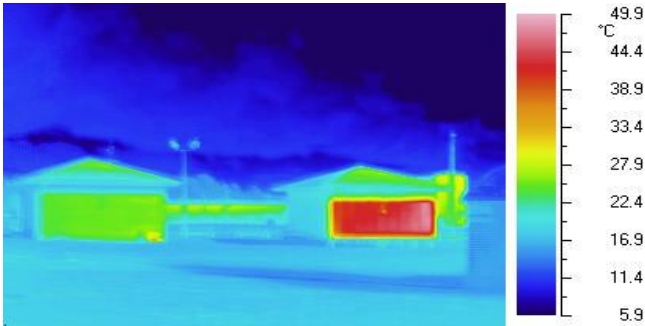
Figure 43: East walls of Test Cell 2 and Test Cell 1 at 11:50 AM 28/09/07

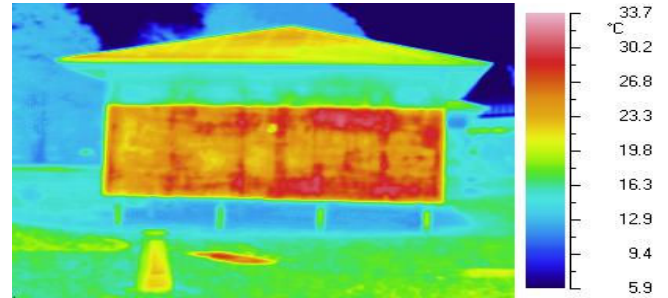
Figure 44: North wall of Test Cell 1 with heater ON 12:05 PM 28/9/07

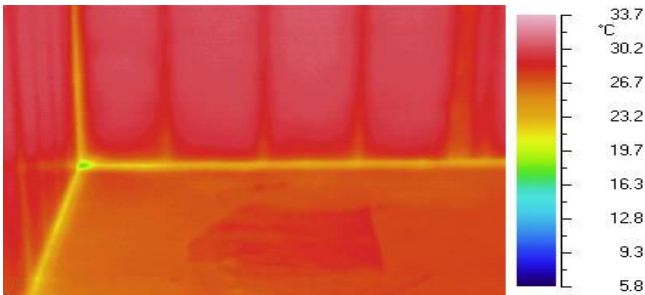
Figure 45: Inside Test Cell 2 with heater ON 2:55 PM 28/09/07

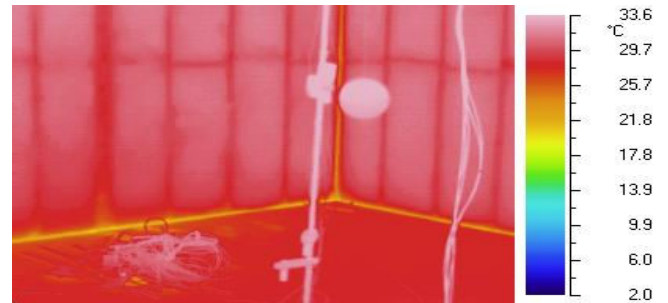
Figure 46: Inside Test Cell 3 with heater ON 2:58 PM 28/9/07

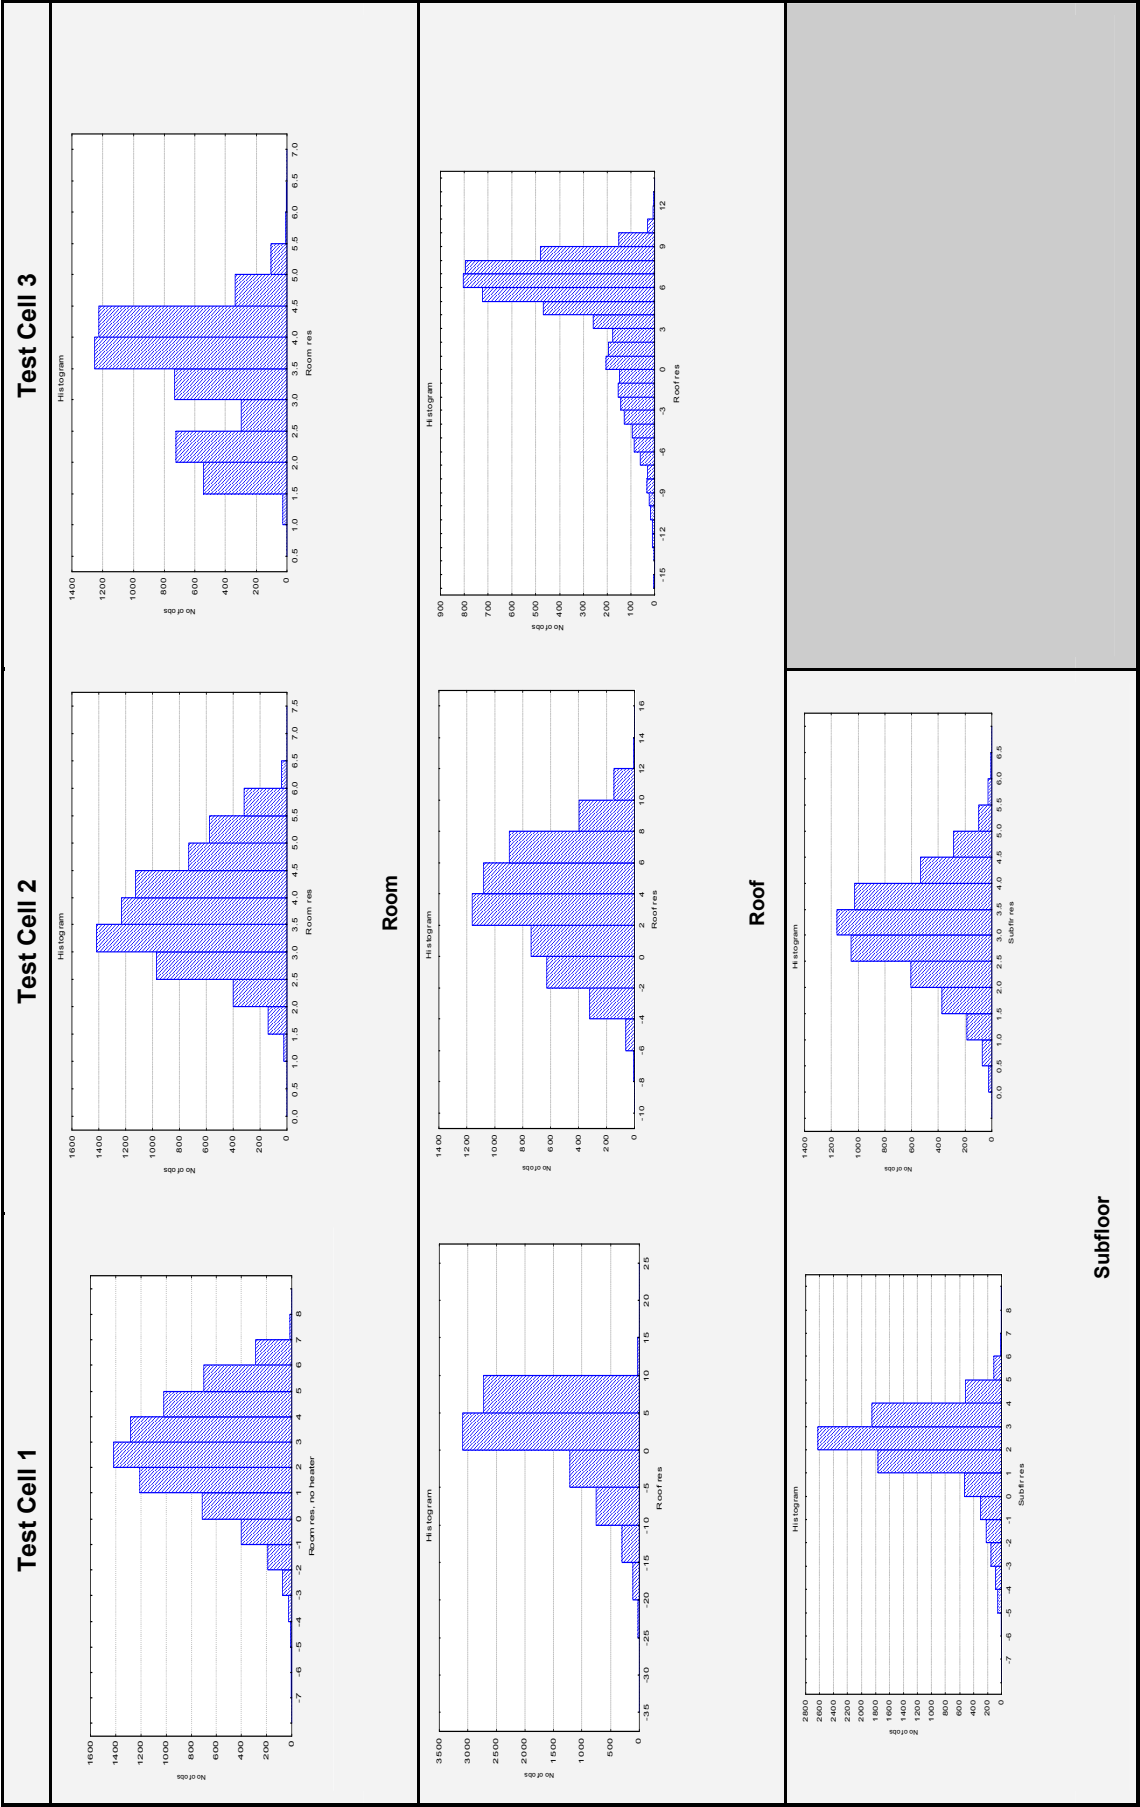
Figure 53 Test Cell Zones Residual Histograms

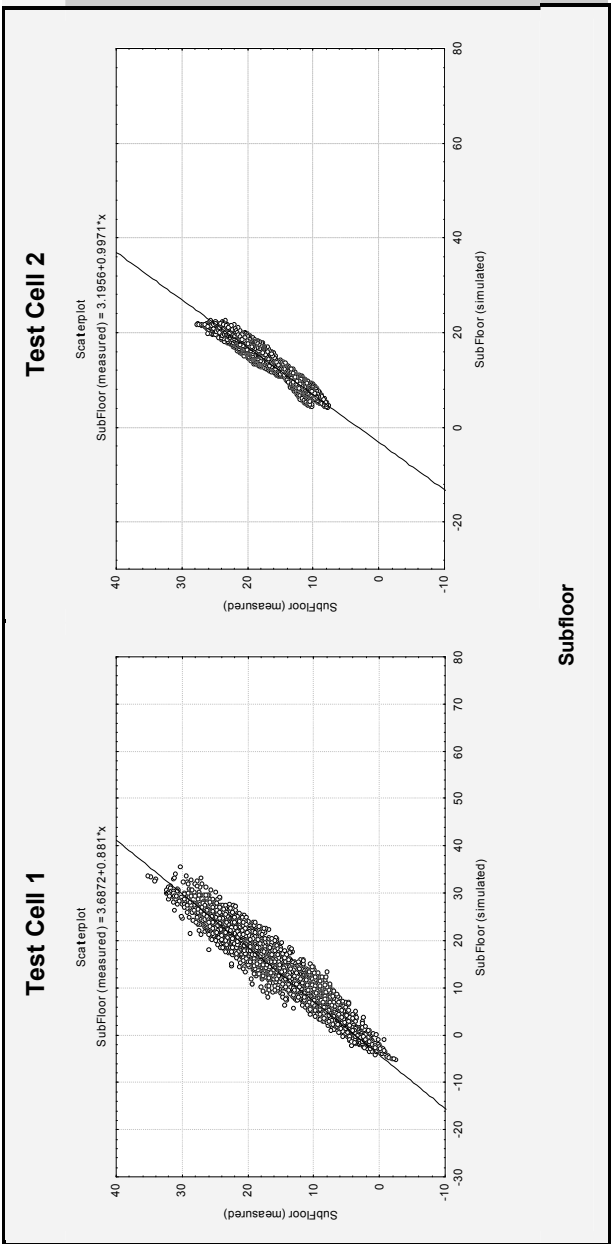
Figure 55B Temperature in Subfloors: Measured vs. Simulated

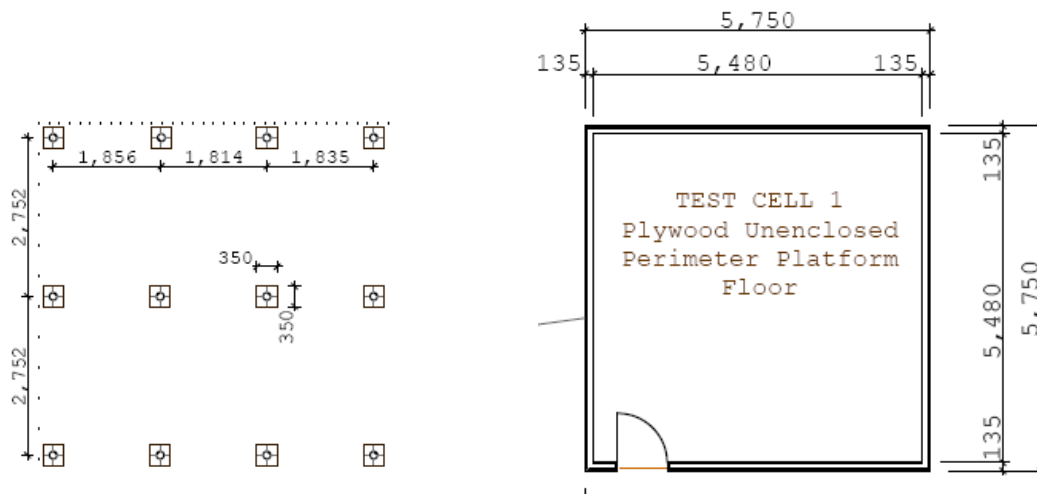
Figure 41: Test Cell 1 Footing Plan & Floor Plan

Item	Specification
Footings	Treated poles set in a concrete pier
Floor	19mm Particle board deck on timber bearer and joists
Walls	10mm Plasterboard, 90mm softwood stud framing, R2.5 rockwool wall batt insulation, reflective foil wrap, 21mm cavity, 12mm plywood lining
Ceiling	10mm Plasterboard, R4.0 Glass wool ceiling batt
Roof	Softwood truss, battens, reflective foil sarking, Colorbond sheet metal roofing

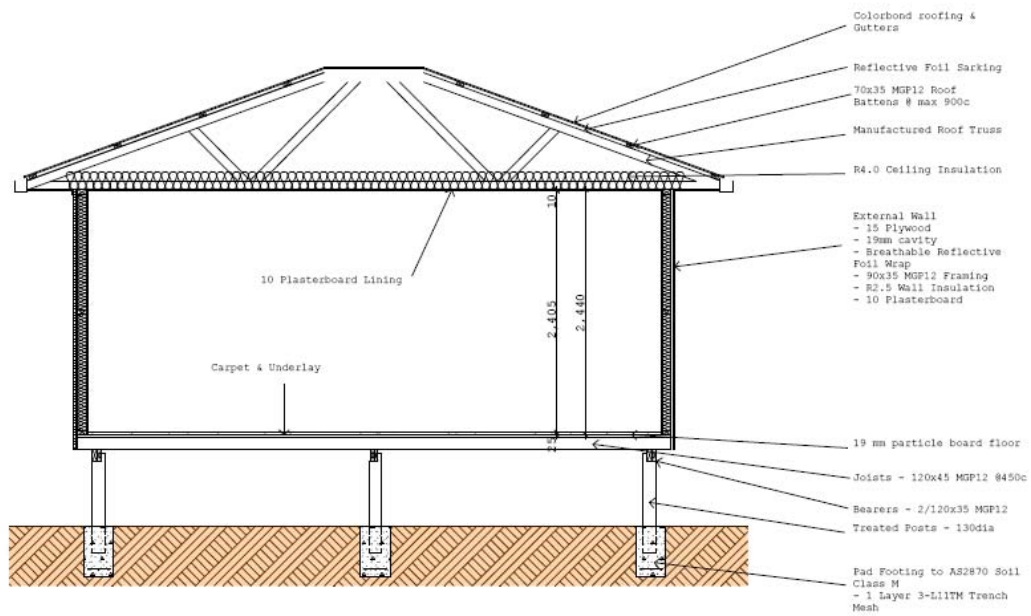
Figure 43: Test Cell 1 Section

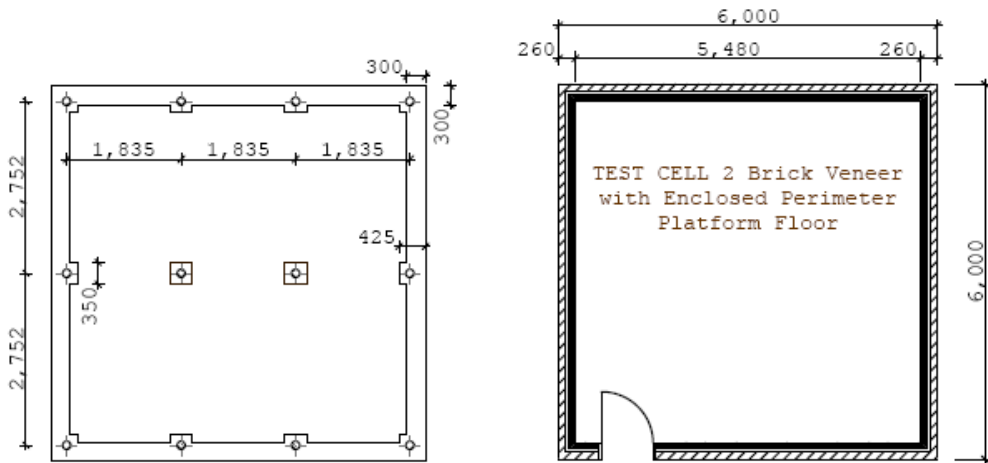
Figure 44: Test Cell 2 Footing Plan & Floor Plan

Item	Specification
Footings	Treated poles set in a concrete pier
Floor	19mm Particle board deck on timber bearer and joists
Walls	10mm Plasterboard, 90mm softwood stud framing, R2.5 rockwool wall batt insulation, reflective foil wrap, 50mm cavity, 110 clay brick
Ceiling	10mm Plasterboard, R4.0 Glass wool ceiling batt
Roof	Softwood truss, battens, reflective foil sarking, Colorbond sheet metal roofing

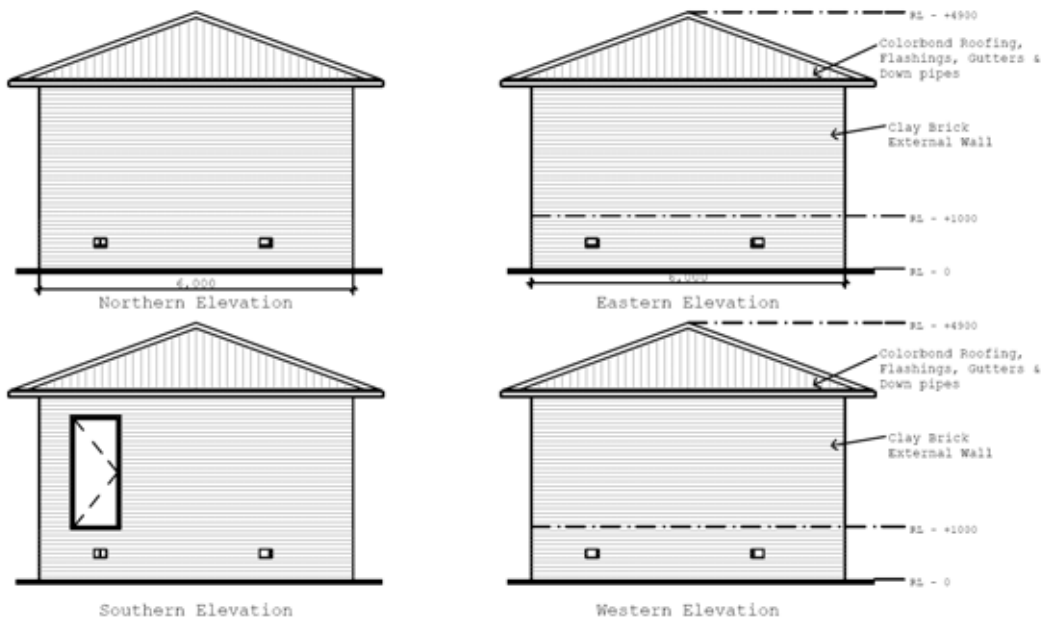
Figure 45: Test Cell 2 Elevations

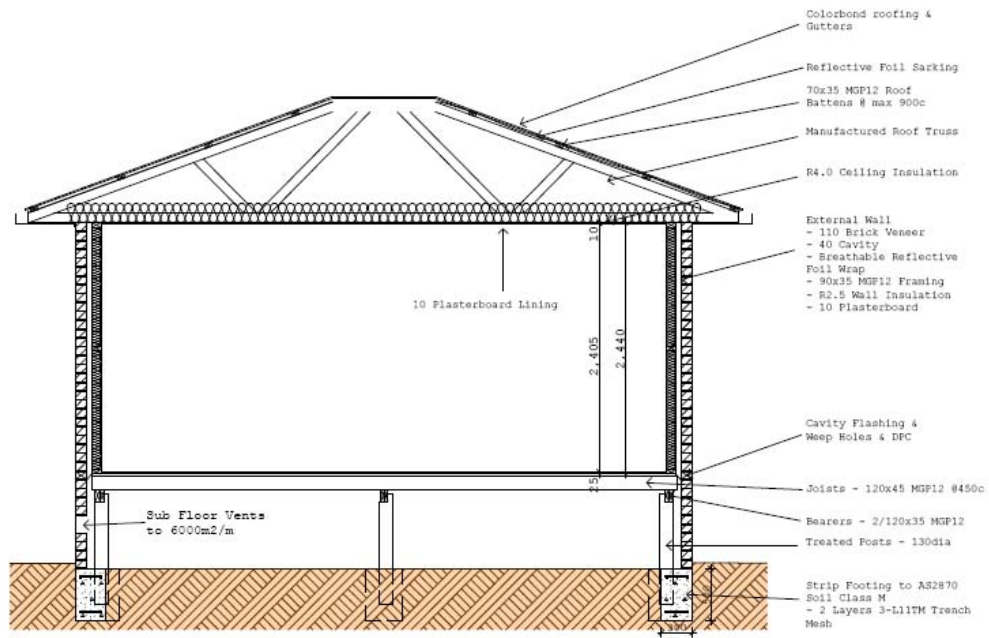
Figure 46: Test Cell 2 Section

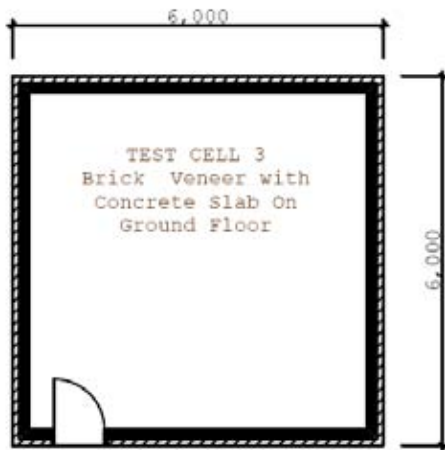
Figure 47: Test Cell 3 Floor Plan

Item	Specification
Floor	100mm Concrete slab on ground
Walls	10mm Plasterboard, 90mm softwood stud framing, R2.5 rockwool wall batt insulation, reflective foil wrap, 50mm cavity, 110 clay brick
Ceiling	10mm Plasterboard, R4.0 Glass wool ceiling batt
Roof	Softwood truss, battens, reflective foil sarking, Colorbond sheet metal roofing

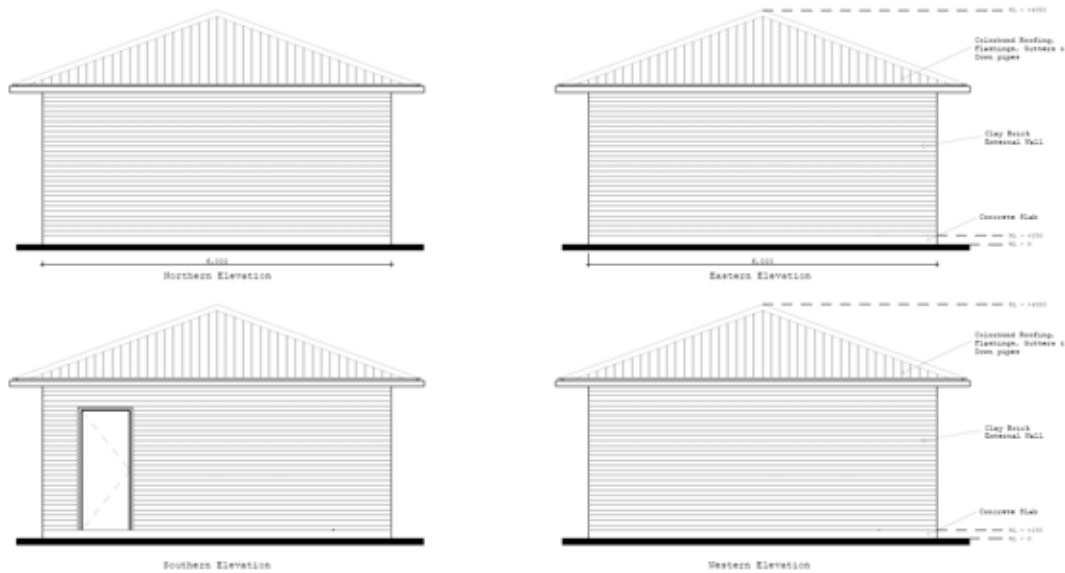
Figure 48: Test Cell 3 Elevations
