Centre for Sustainable Architecture with Wood

Comparison of Test Cell Thermal Performance & The Empirical Validation of AccuRate in a Cool Temperate Climate

FWPRDC project PN04.1009

Final Report

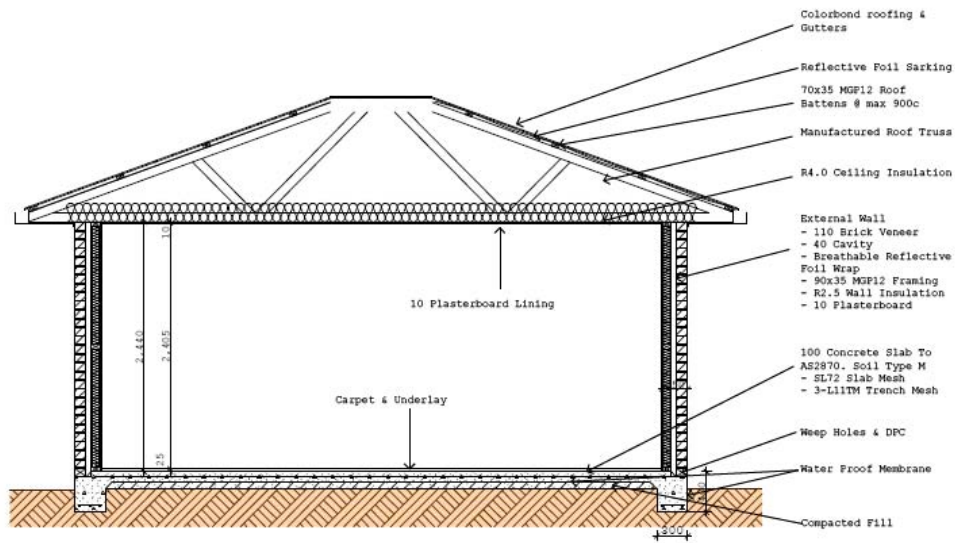
Figure 49: Test Cell 3 Section
